REDESIGN AND RECONSTRUCTION OF STORMWATER OUTFALLS

Steve Adams, Engineering

Morey's Landing July 2011 - First Call

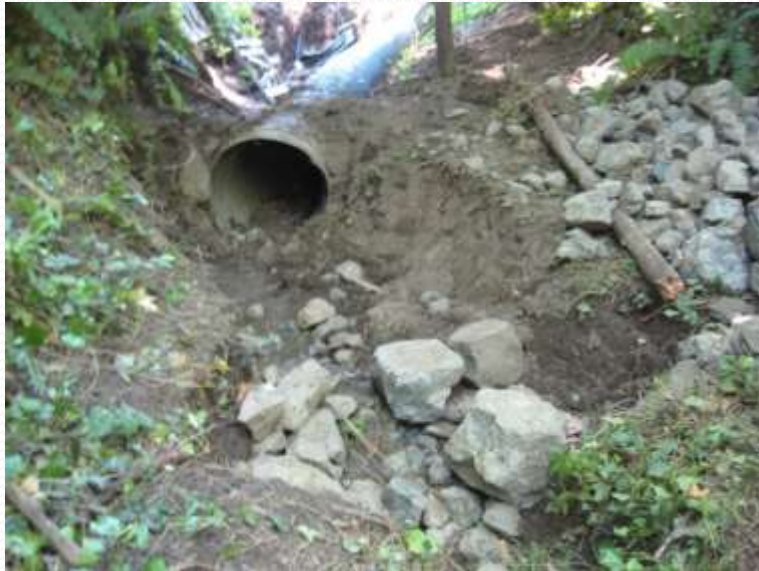
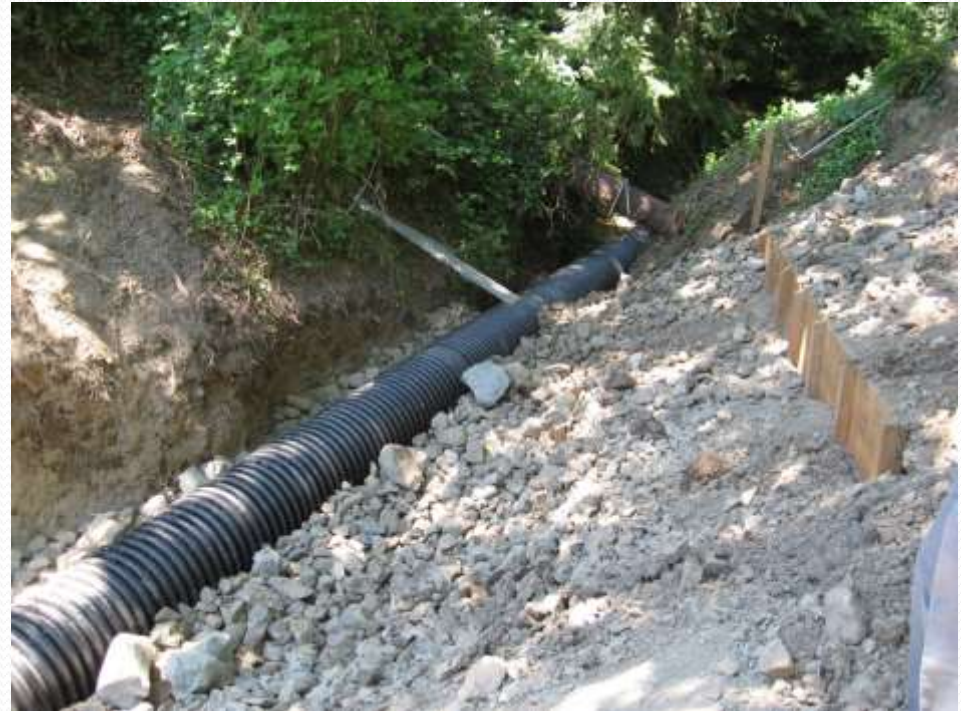
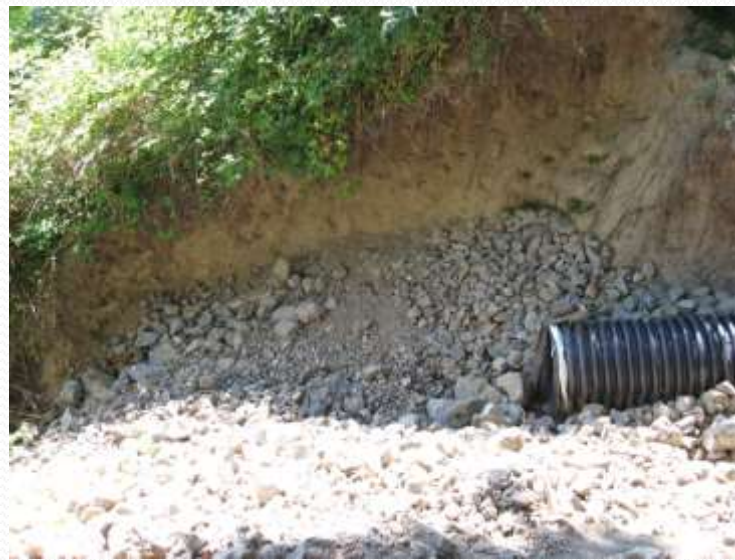
A very industrious homeowner
working without permits

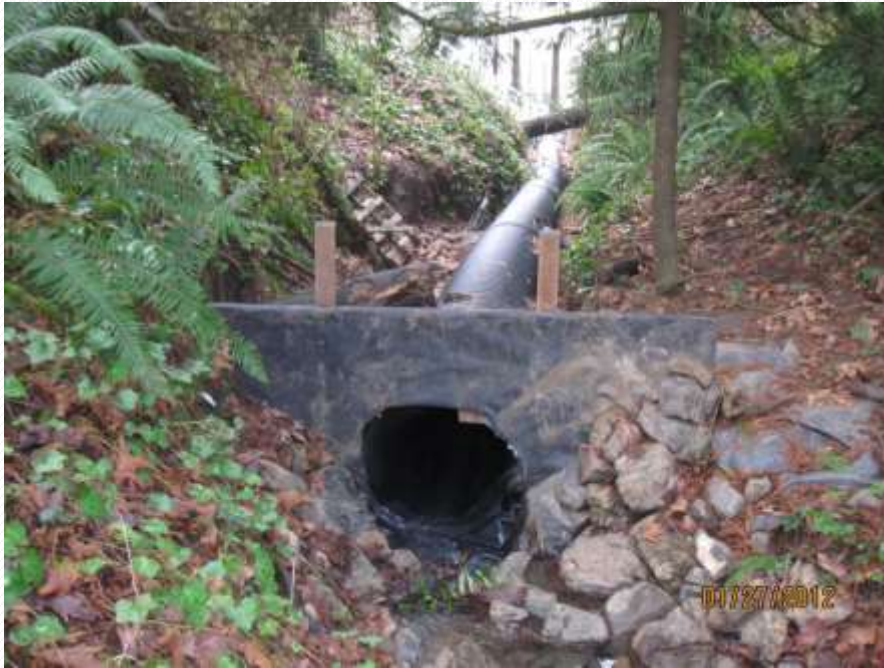
Headwall

Temporary measures approved by
Army Corps of Engineers –
constructed October 2011

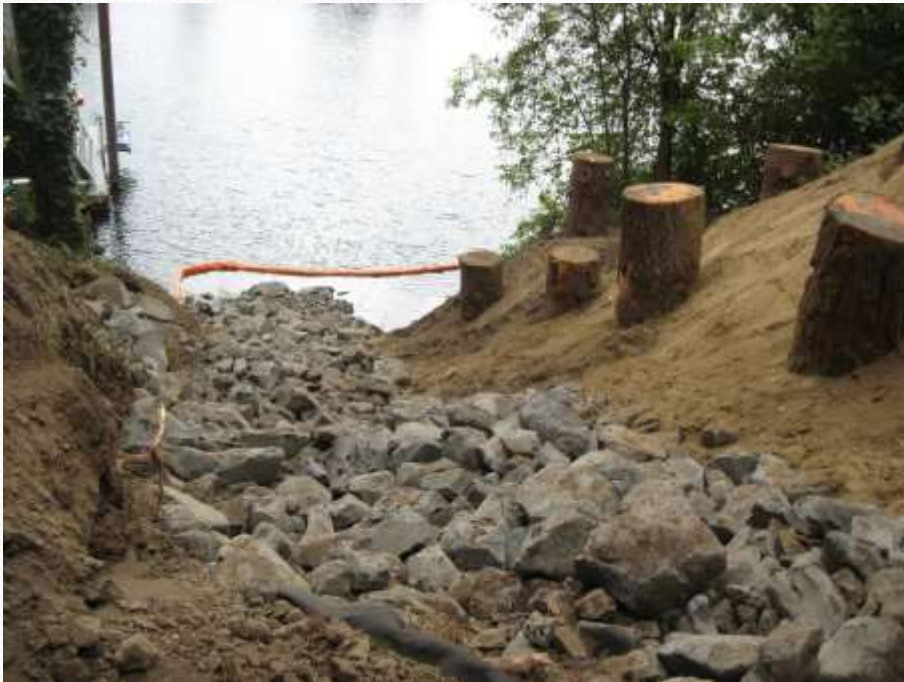
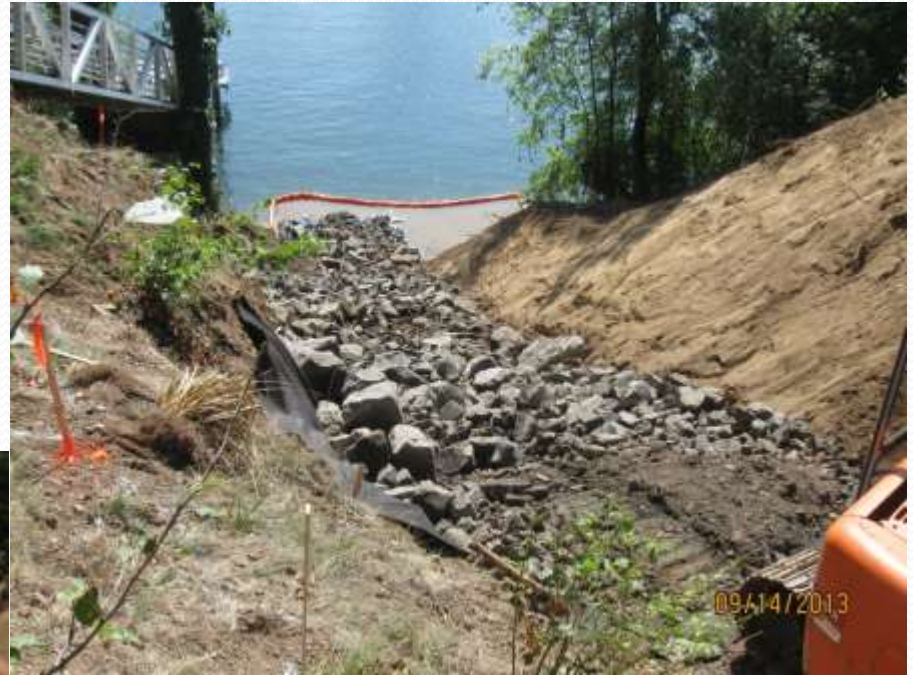
Late August / early
September 2013 –
initial construction of
lower rock ramp

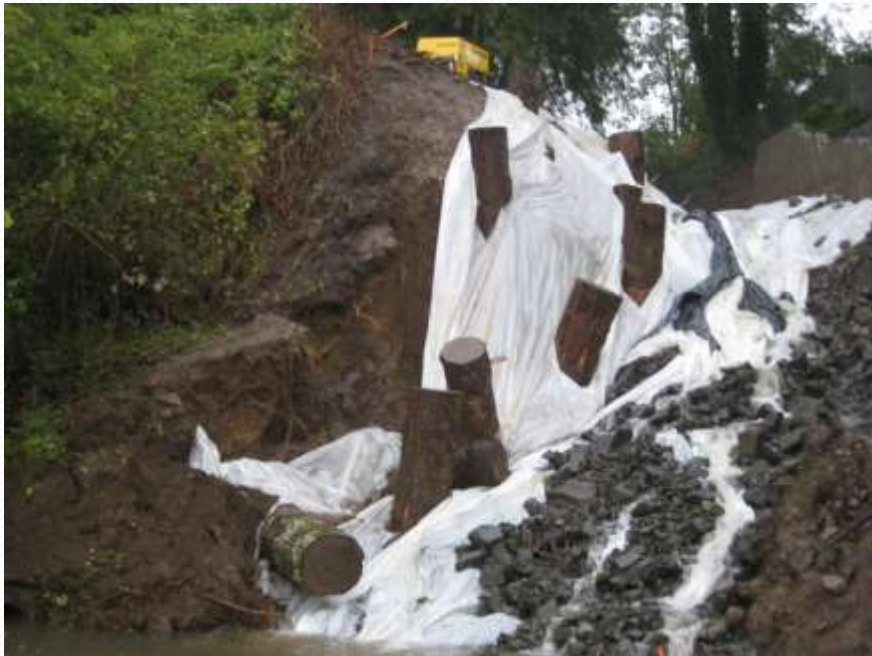
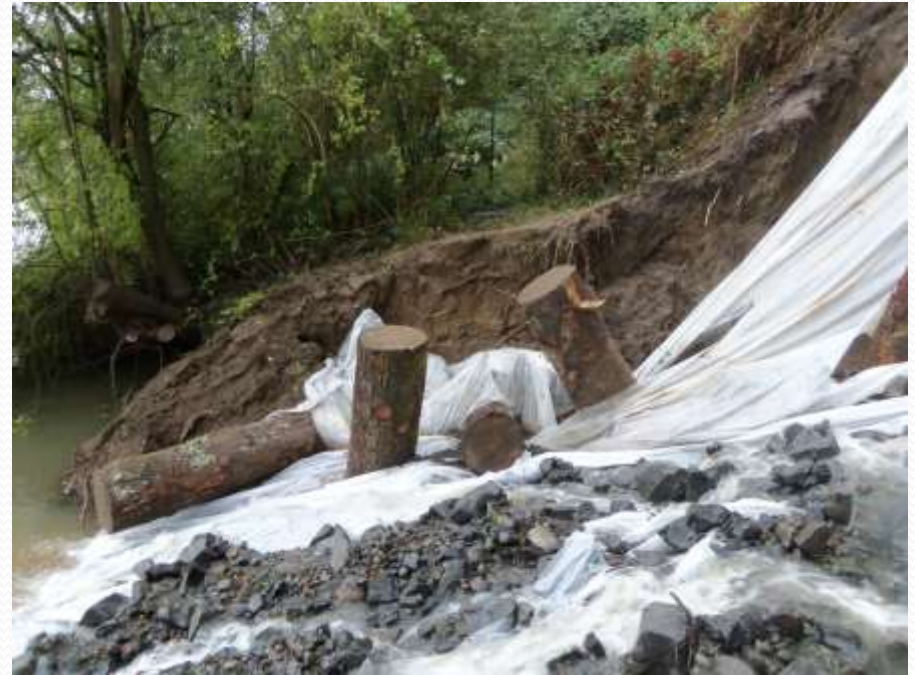
Effects of a monsoonal rain event
 $\pm 5''$ over 3 days, September 2013
and a change in repair plans

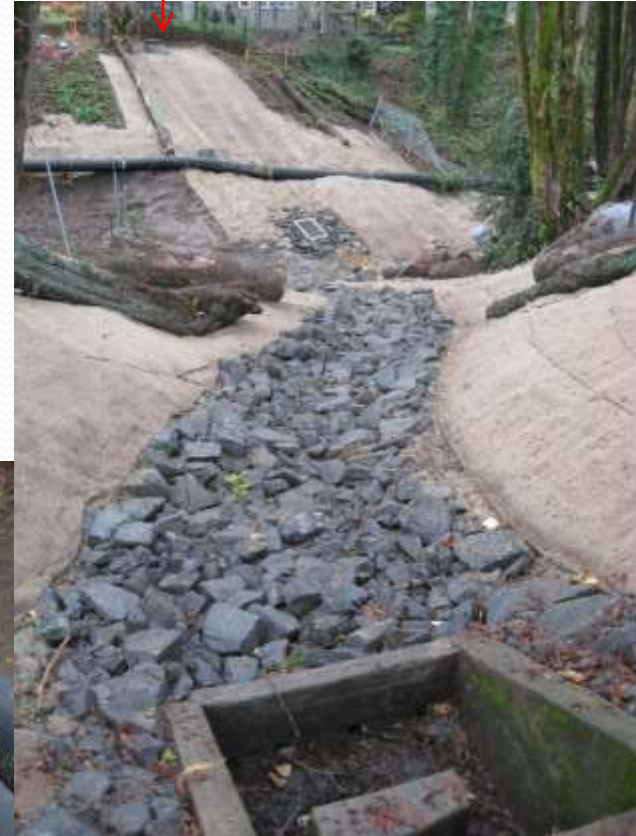
Manhole is in original
location of east side outfall

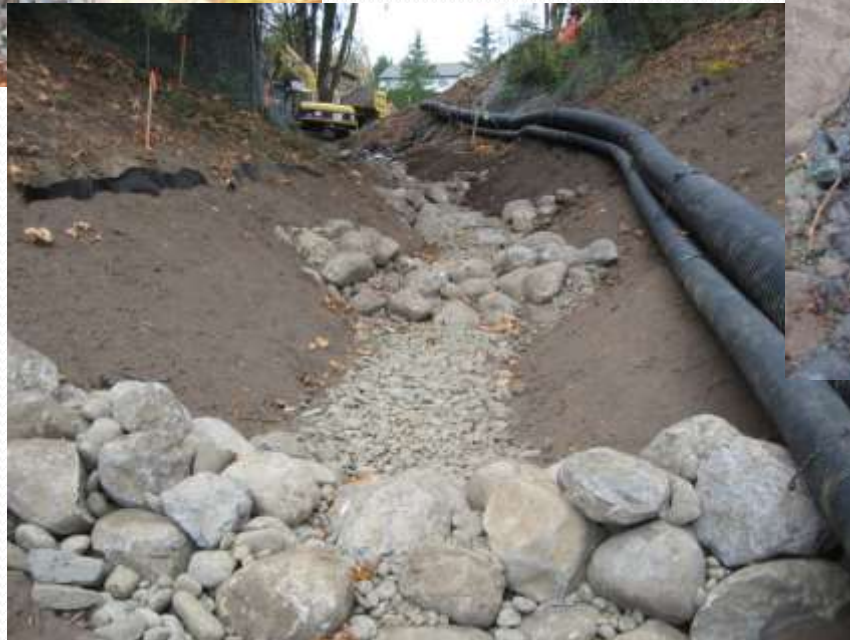
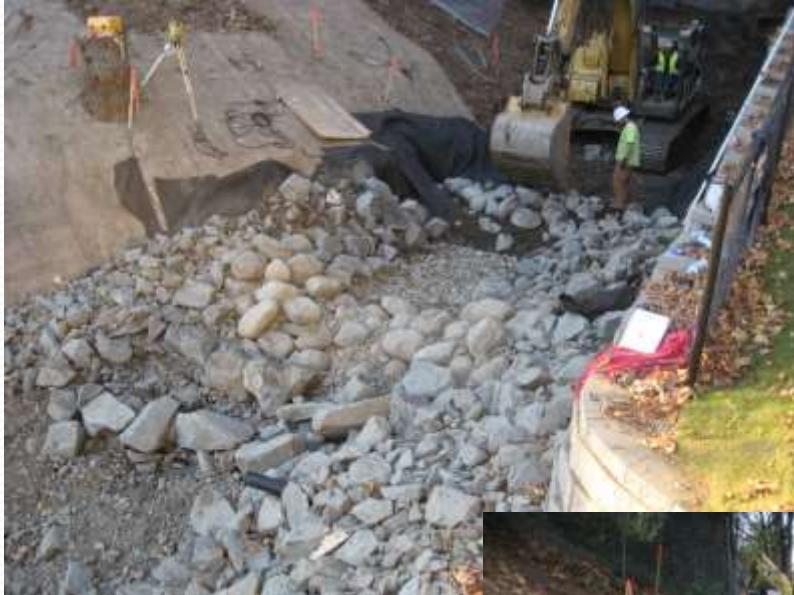
Transition from
rock ramp to
step pools

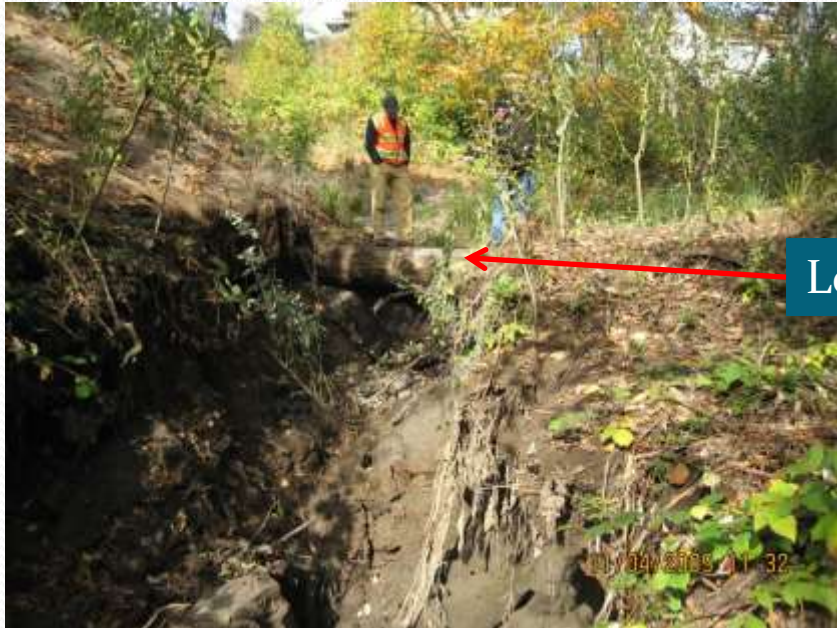
Lowest Log Step

Work completed in September 2009,
first signs of failure in October 2009,
below the constructed log steps

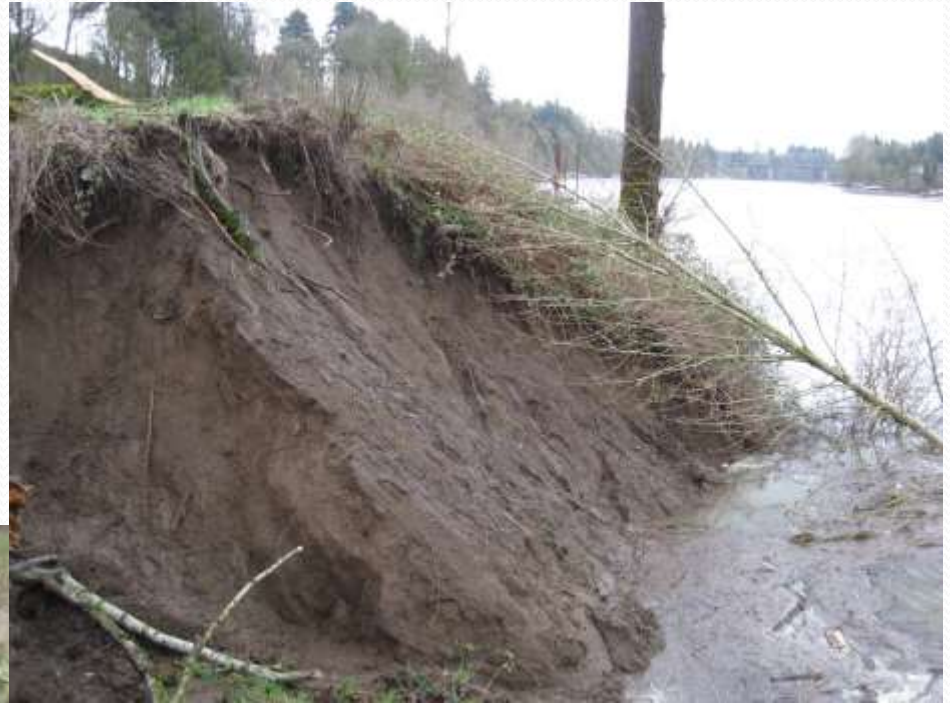
Bank failure, March 2011
- a change in repair plans

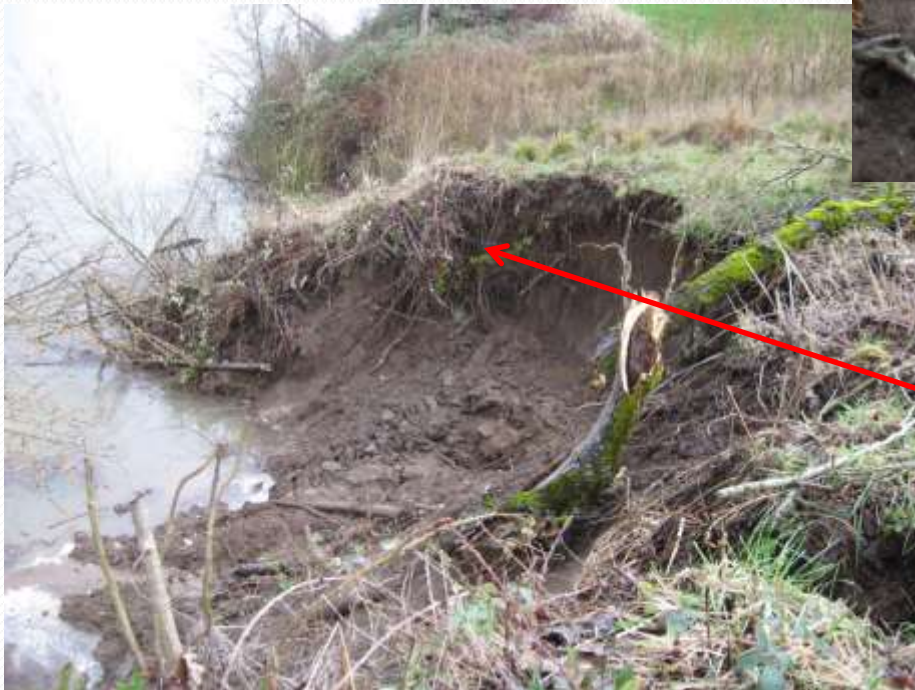
±25 ft from top of
bank to river level

MSE stabilized
bank from
2009 repairs
