**FOG**

**CHRONICLES**

**ORWEF March 2017**

**Grease Caused  
Sanitary Sewer Overflows  
2008 - 2013**

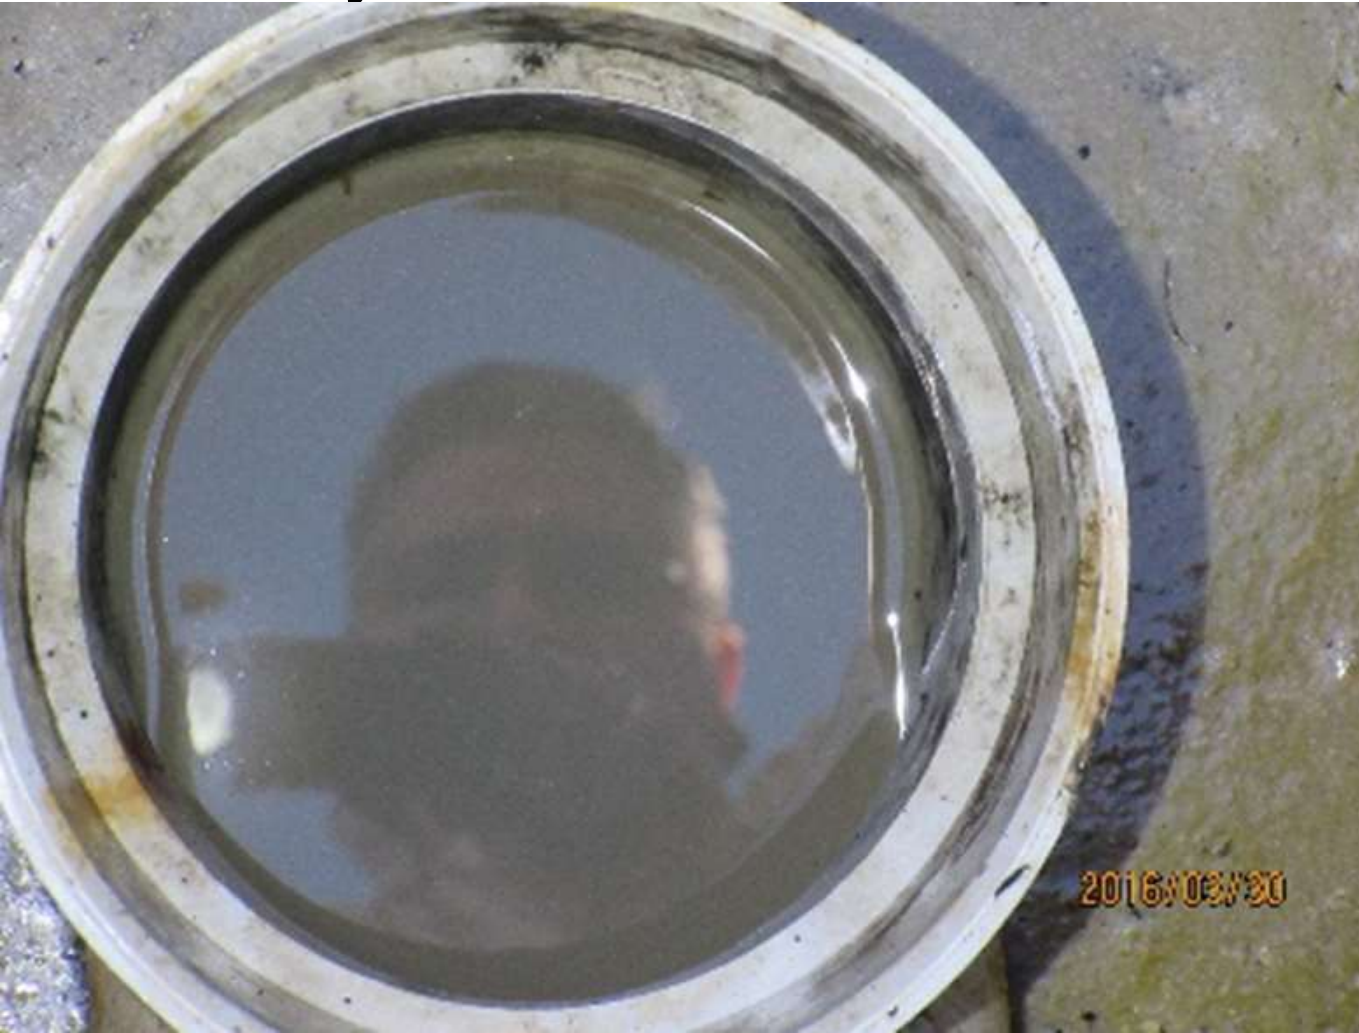
**20 days in service**

- Very heavy food production
- Plumbing Engineer's design - anticipated 90 days

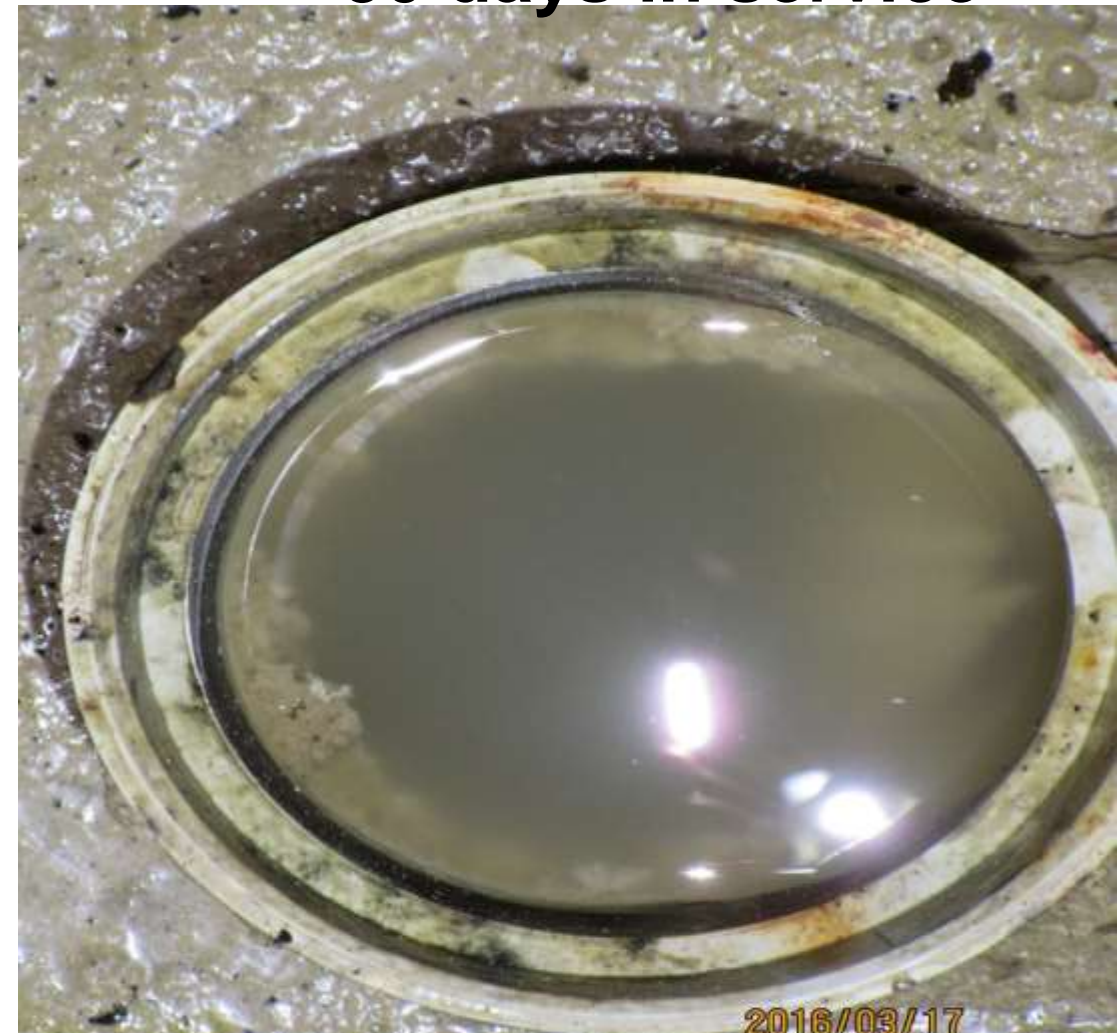
**30 days in service**

## Discovery Frequency – 30 days / likely to be 24 - 26 days

- Works out fine for the Sewer Agency
- Not so fine for long term operational costs

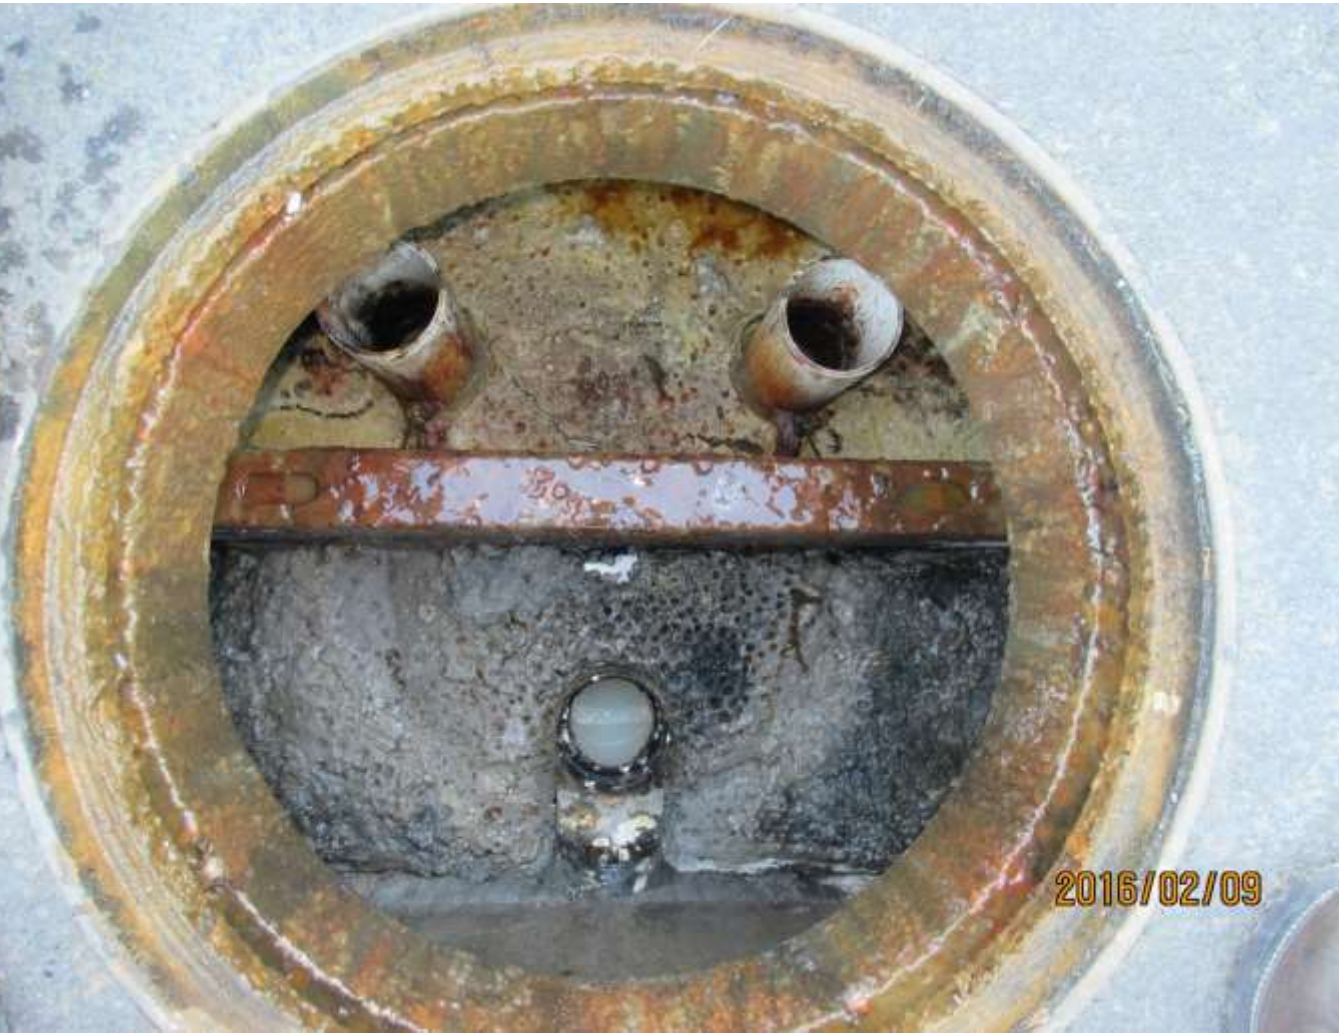
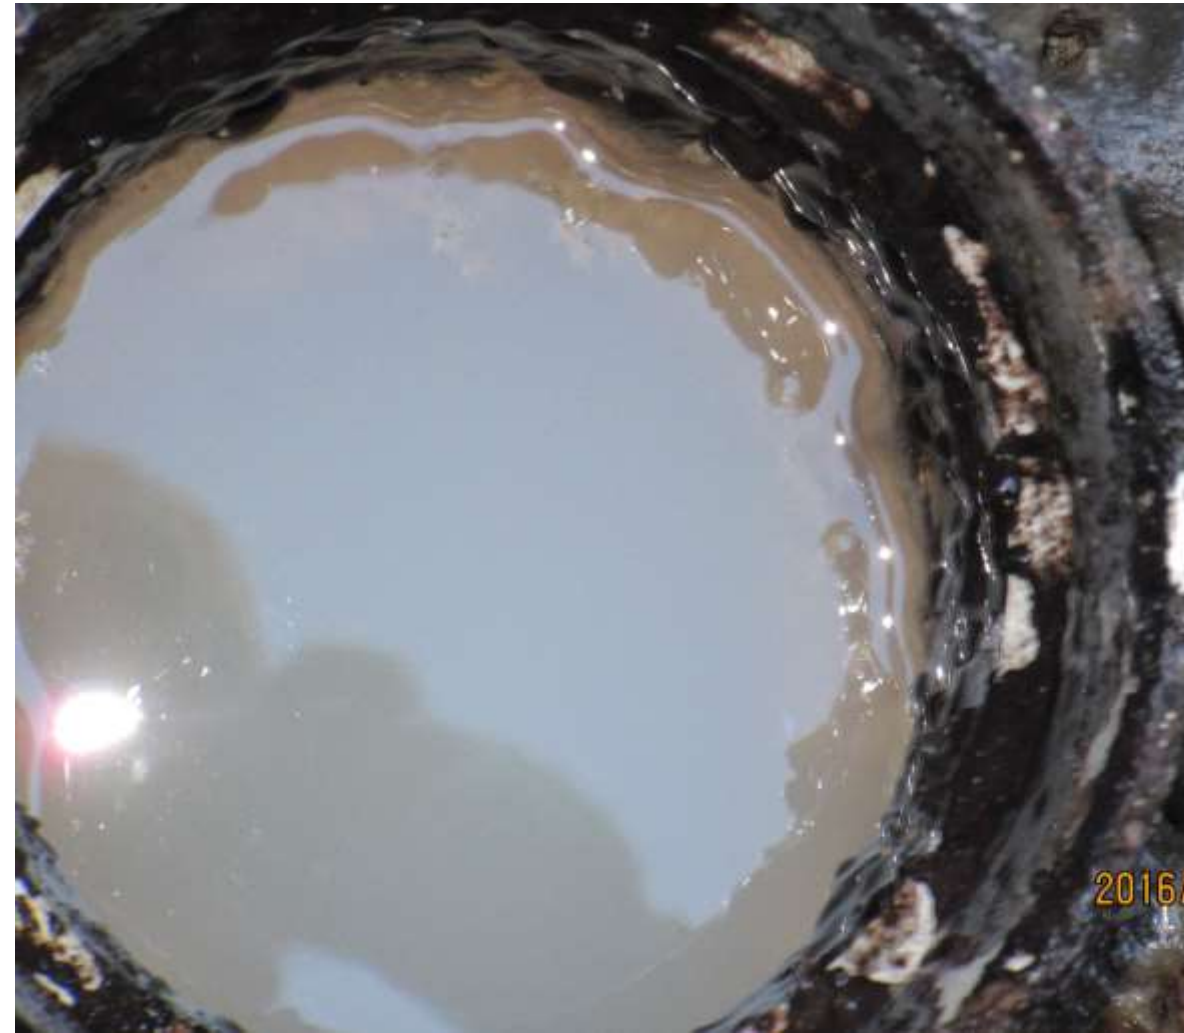
## 69 days in service - Very Heavy By-Pass

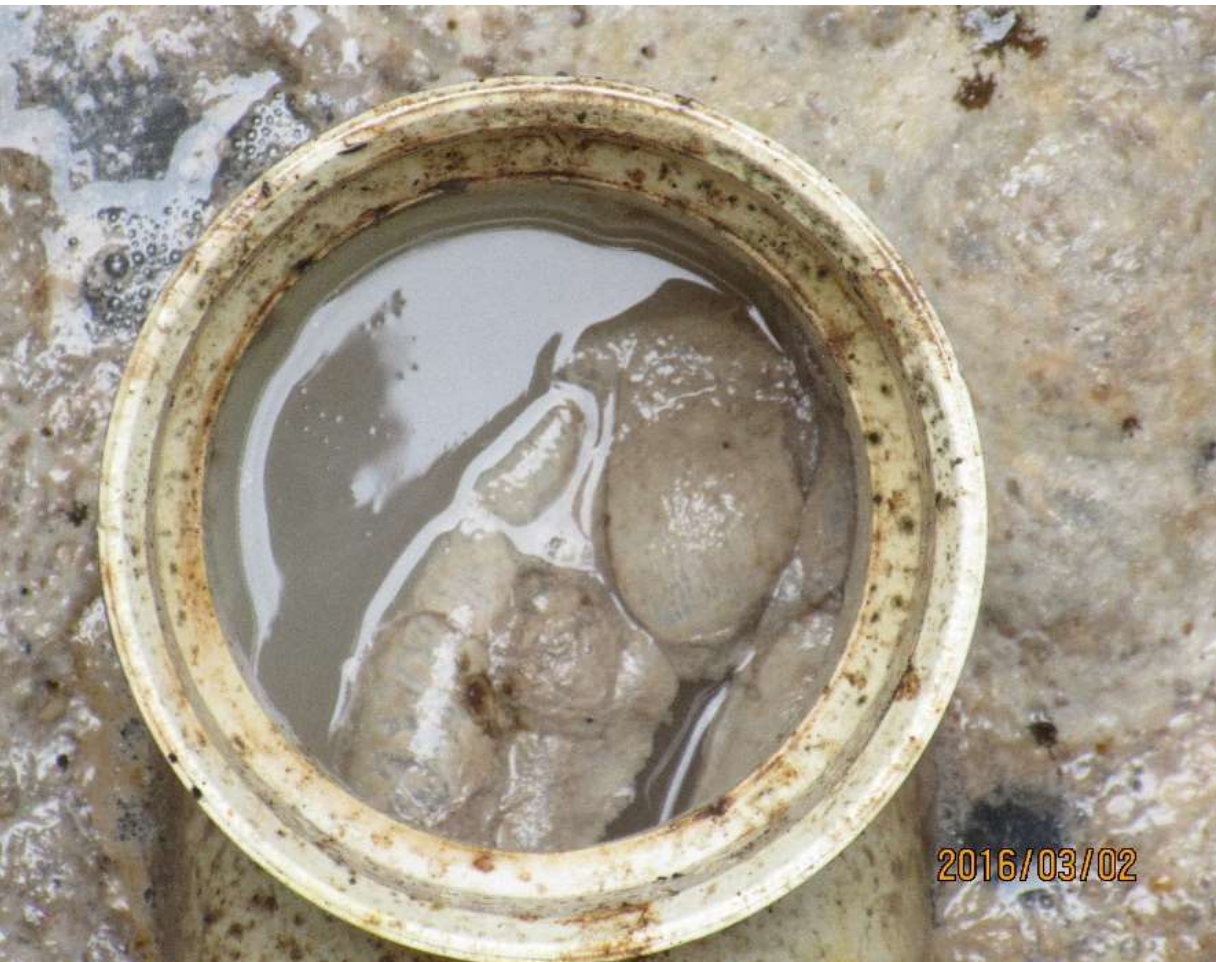
**22 days in service**

- Heavy food production
- Expecting to take over sales from Wilsonville & Beaverton
- Plumbing Engineer's design - anticipated 90 days (1<sup>st</sup> spec 1000 gallon)

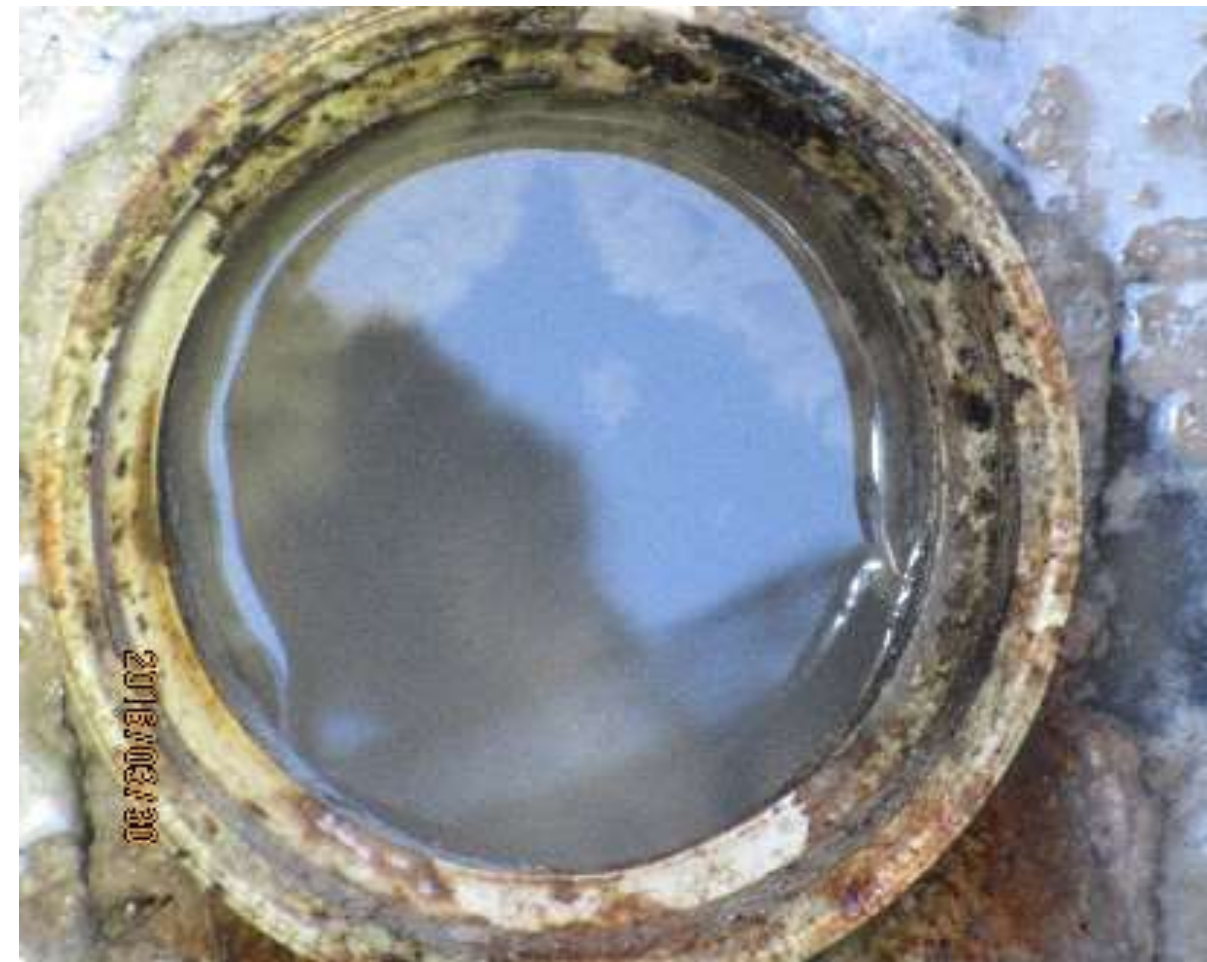
**43 days in service**

## Regulatory Frequency – 30 days

- Works out fine for the Sewer Agency
- Not so fine for long term operational costs

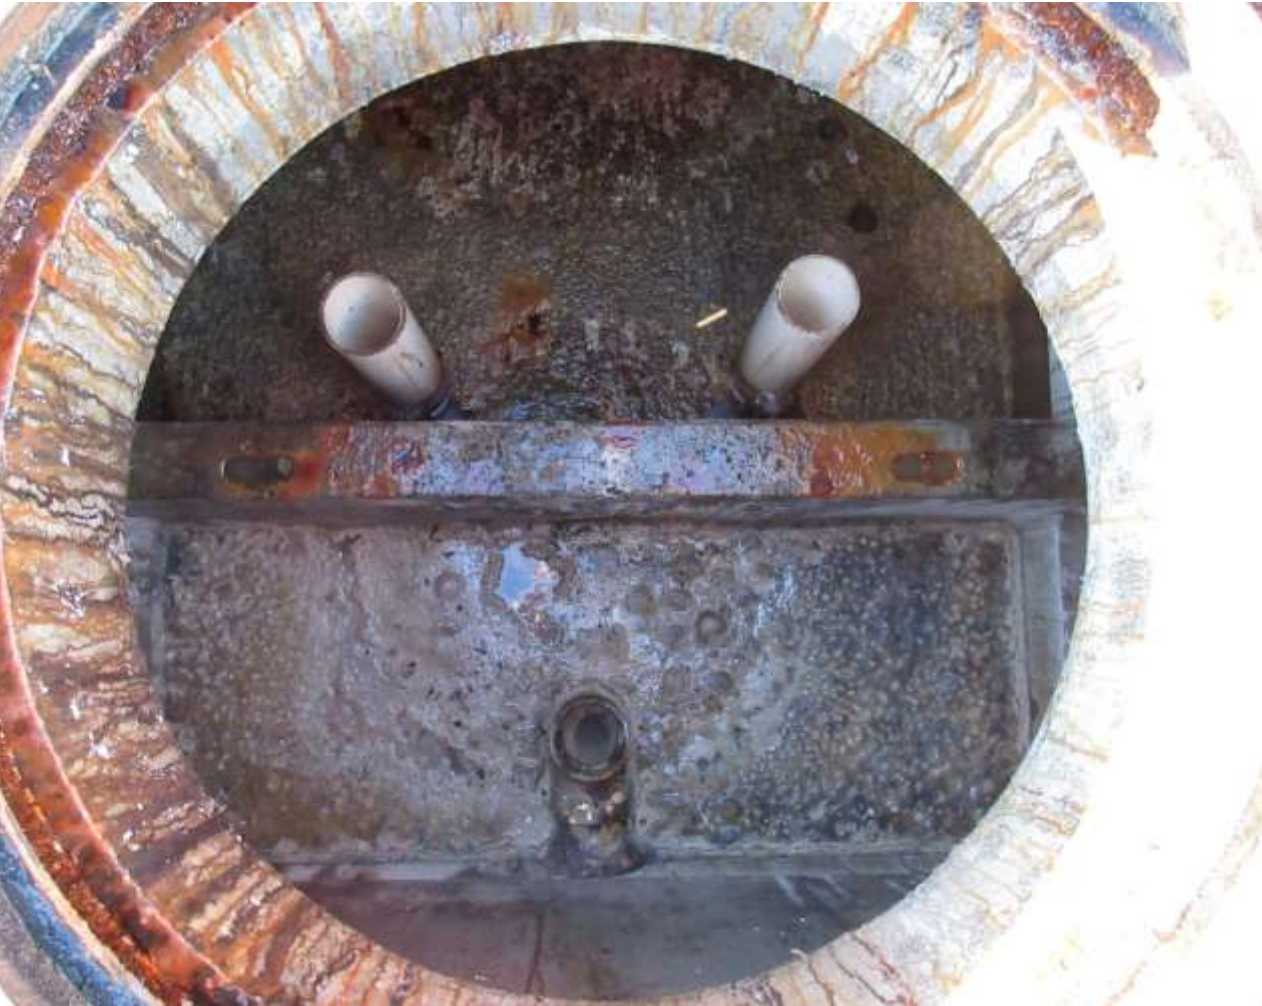
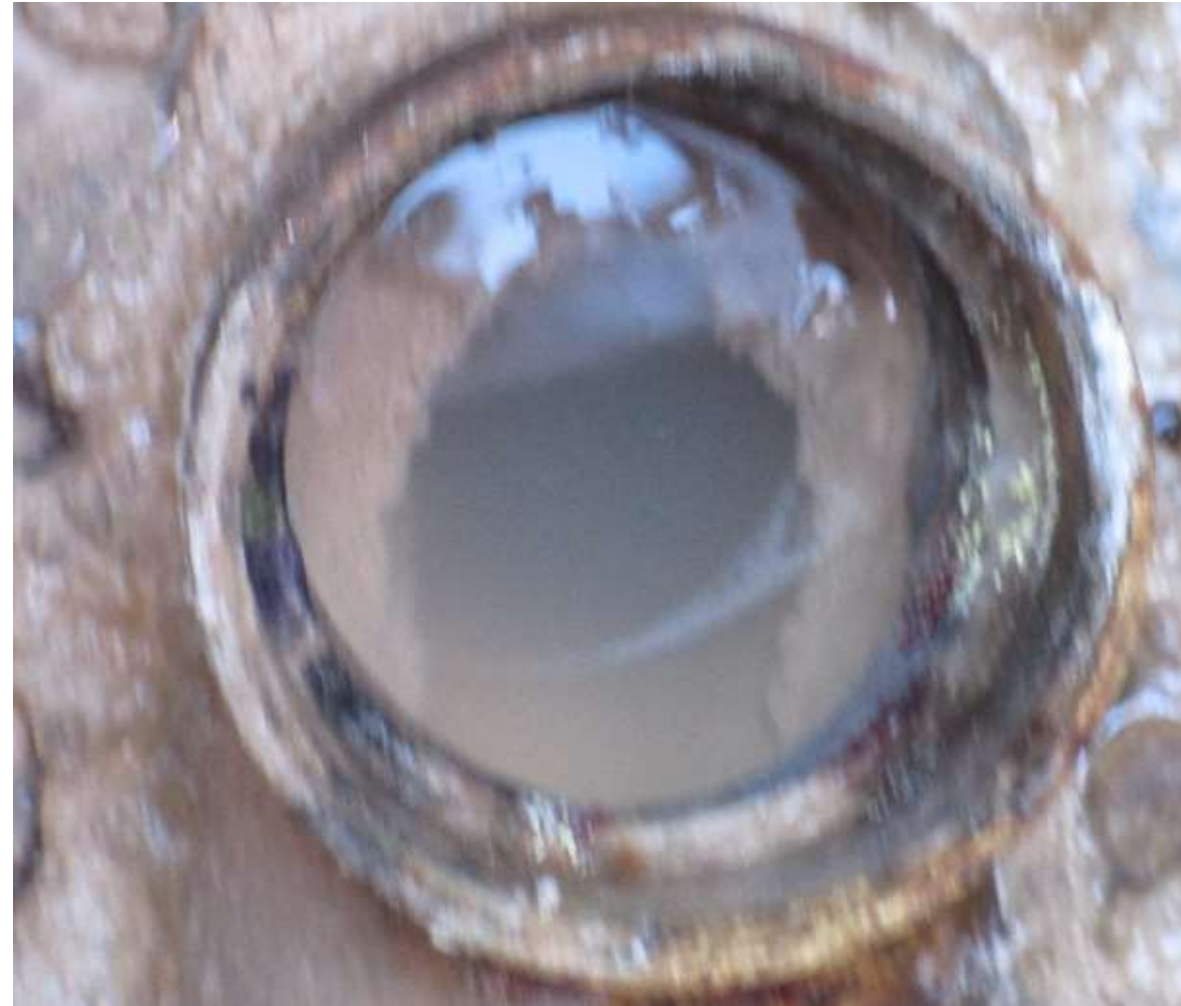
## **73 days in service - Heavy By-Pass**

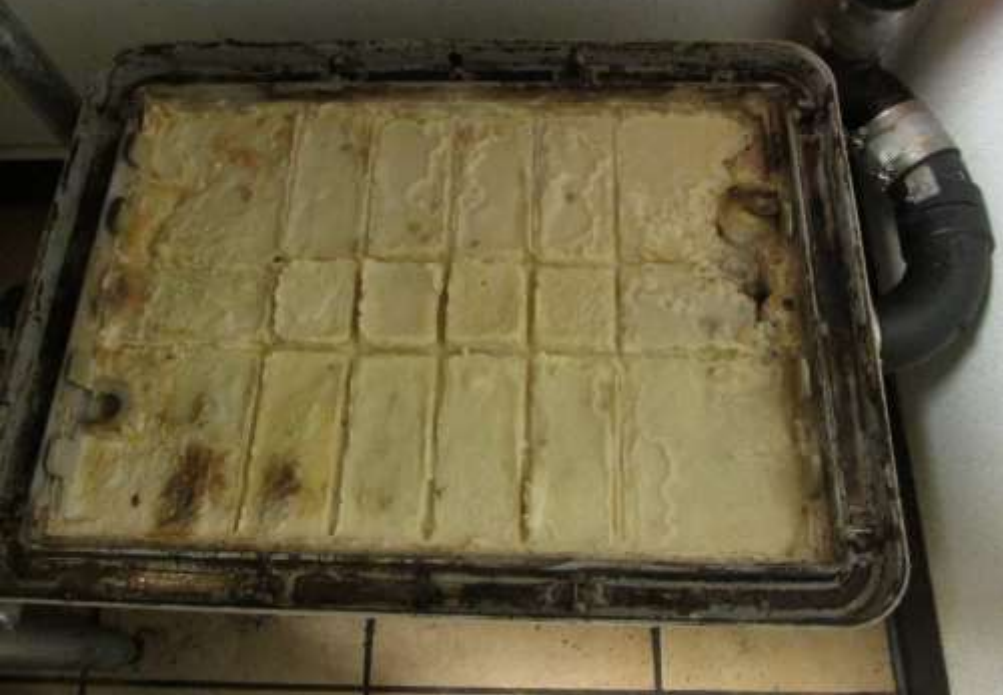
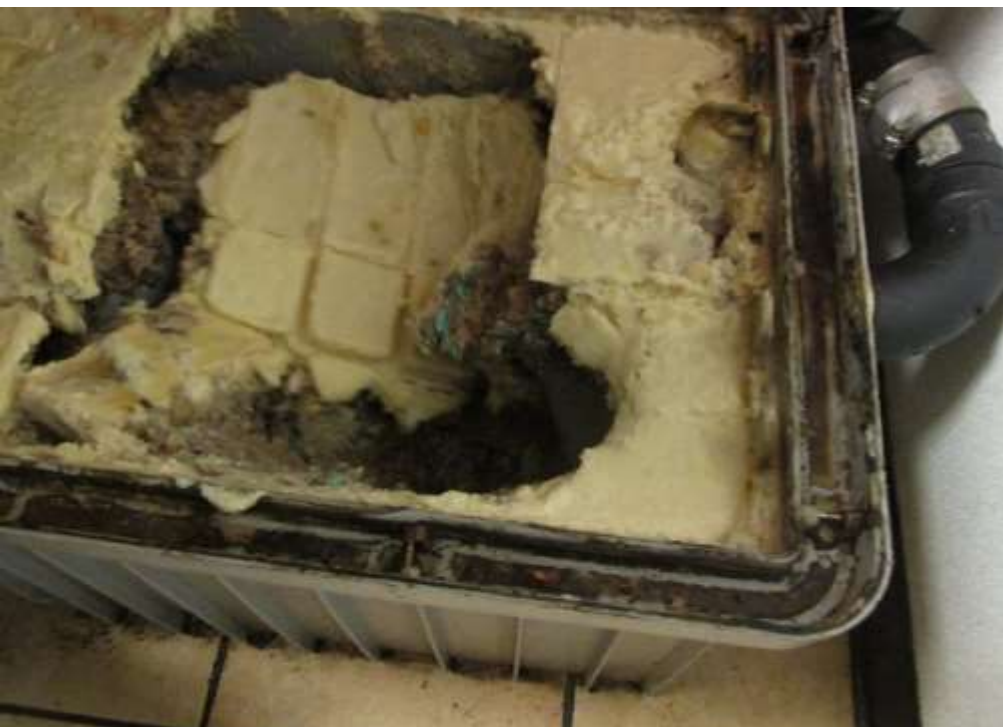
### Same size of HGI

- Dishwasher is hooked-up
- Except drains in upper right photo
- HGI too small for operation
- Flushing out HGI and pushing to Public

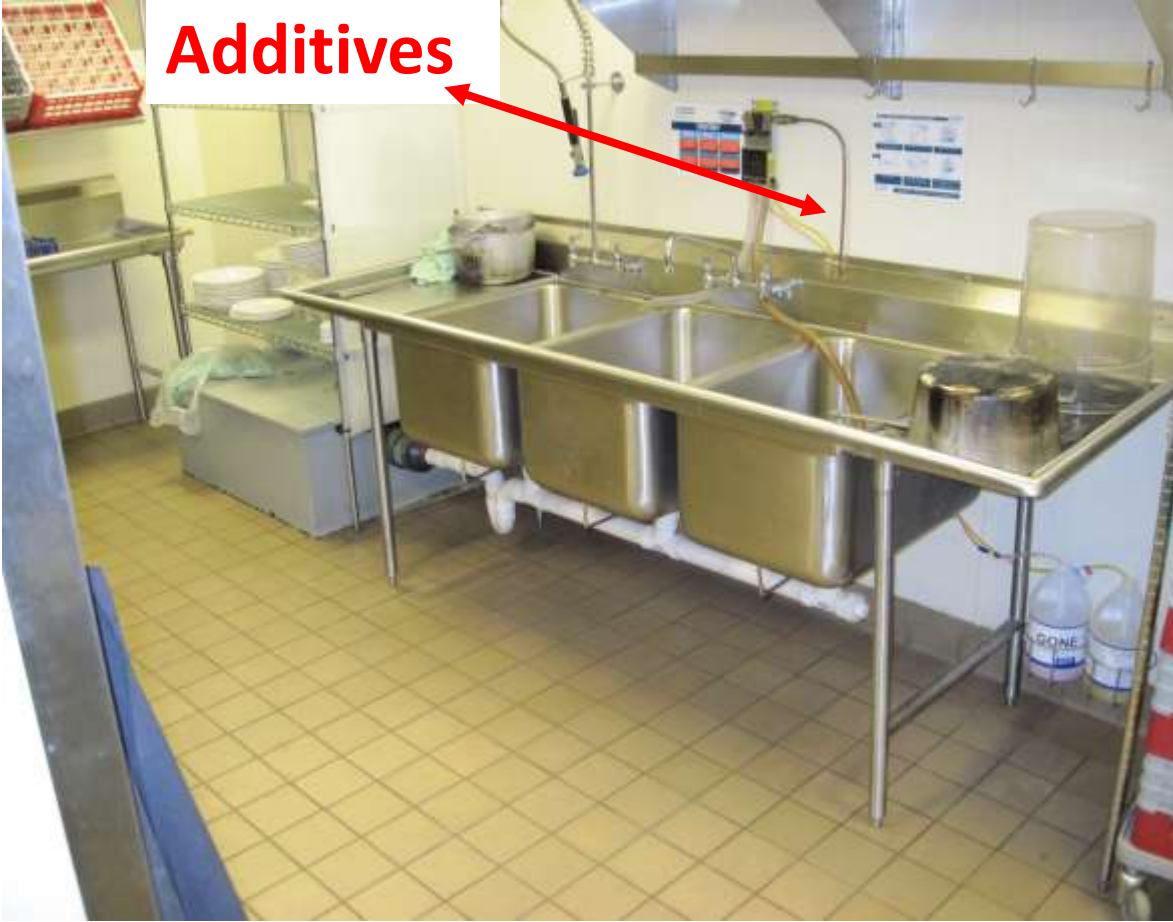
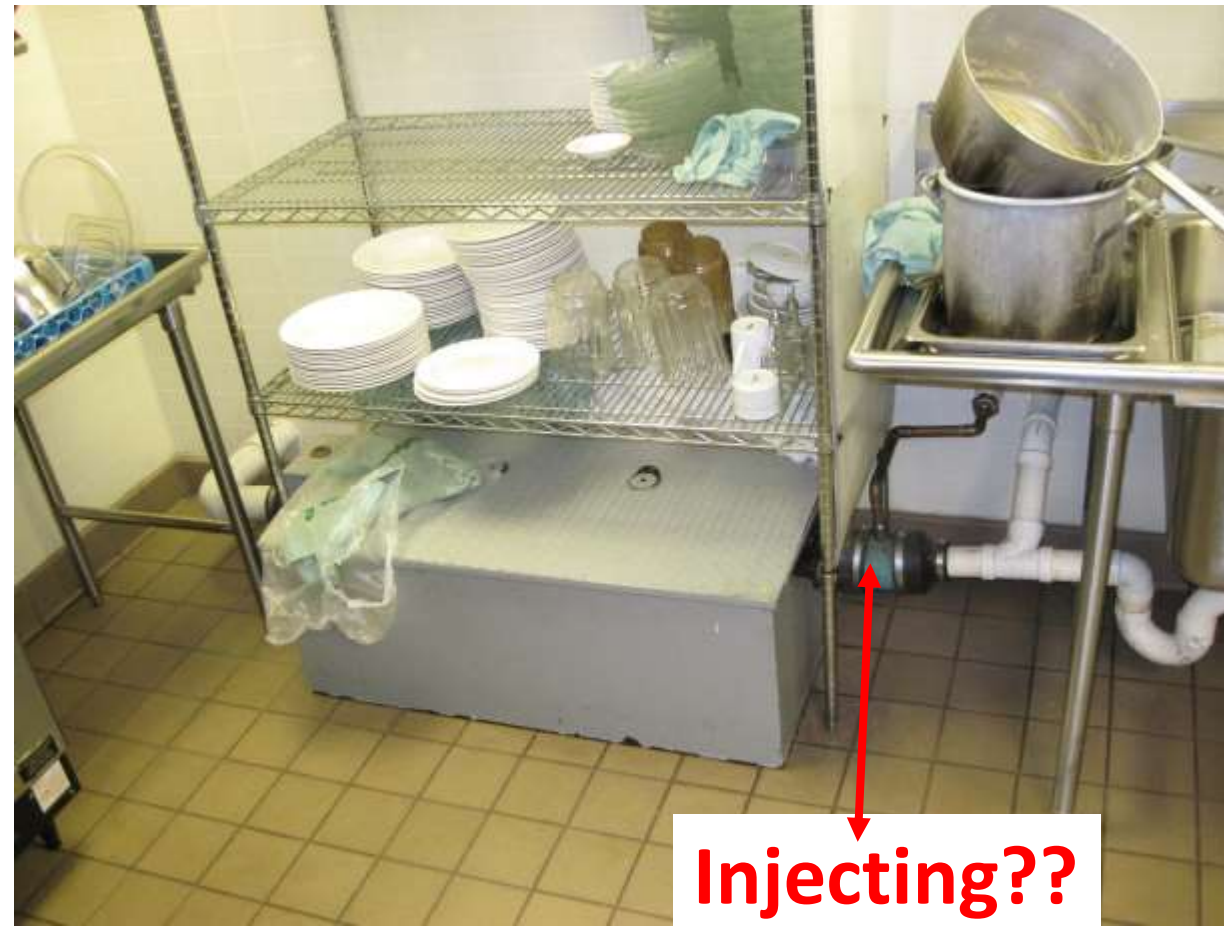
**Injecting??**

**FOG abatement system Hydromechanical Grease Interceptor (HGI) 50/100**

**3 comp sink plus two other connections.**

**One of the connections is being used for additives to by-pass the HGI**

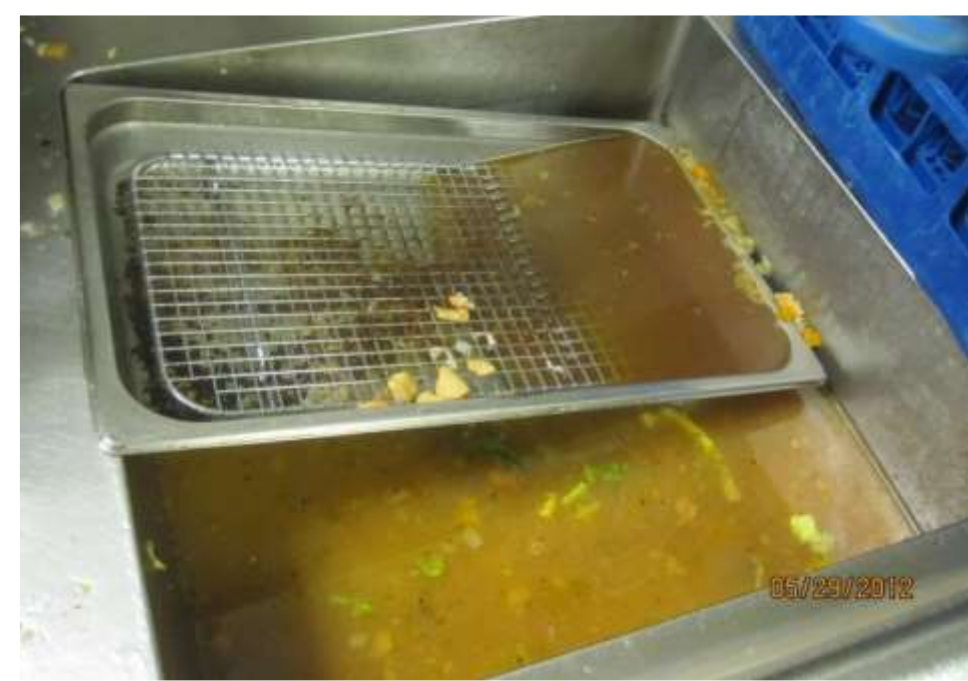
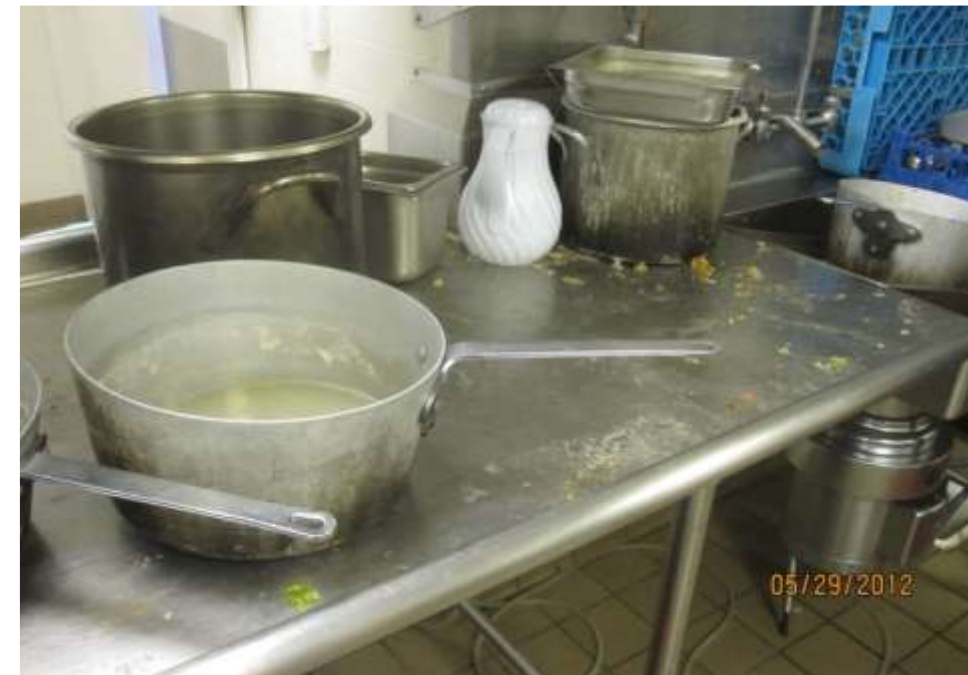
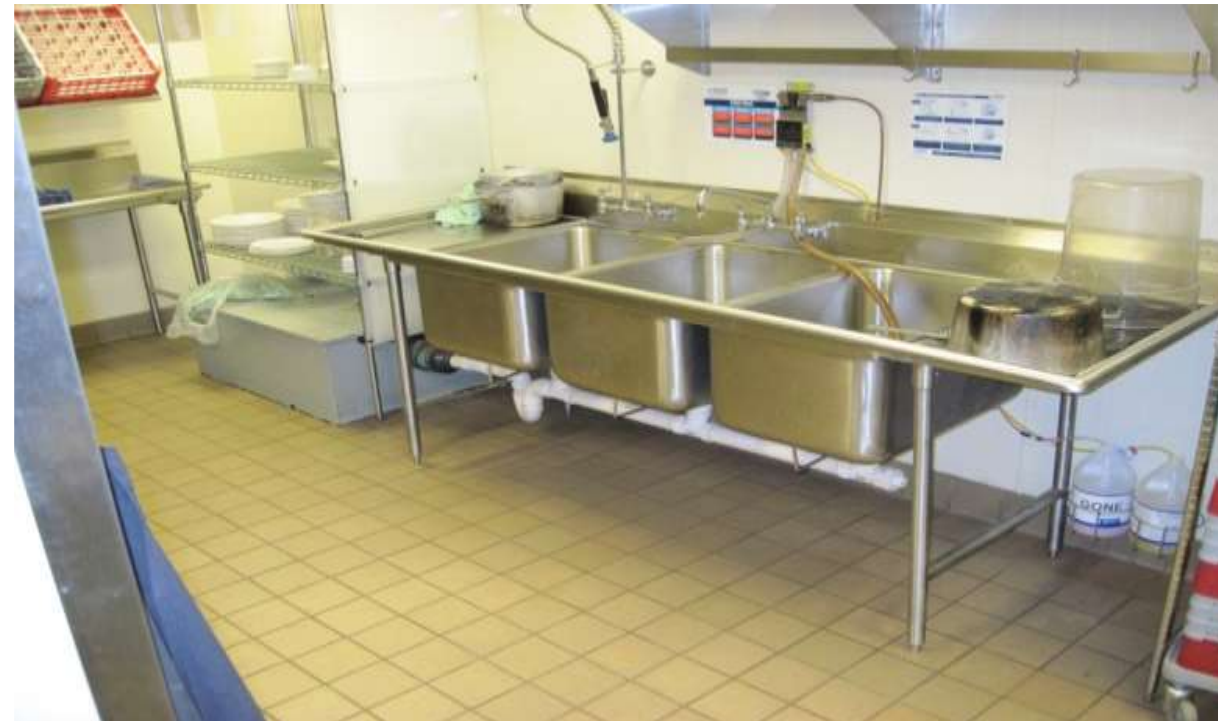
# Pre-wash/garbage grinders & Dishwasher

are not  
providing FOG protection

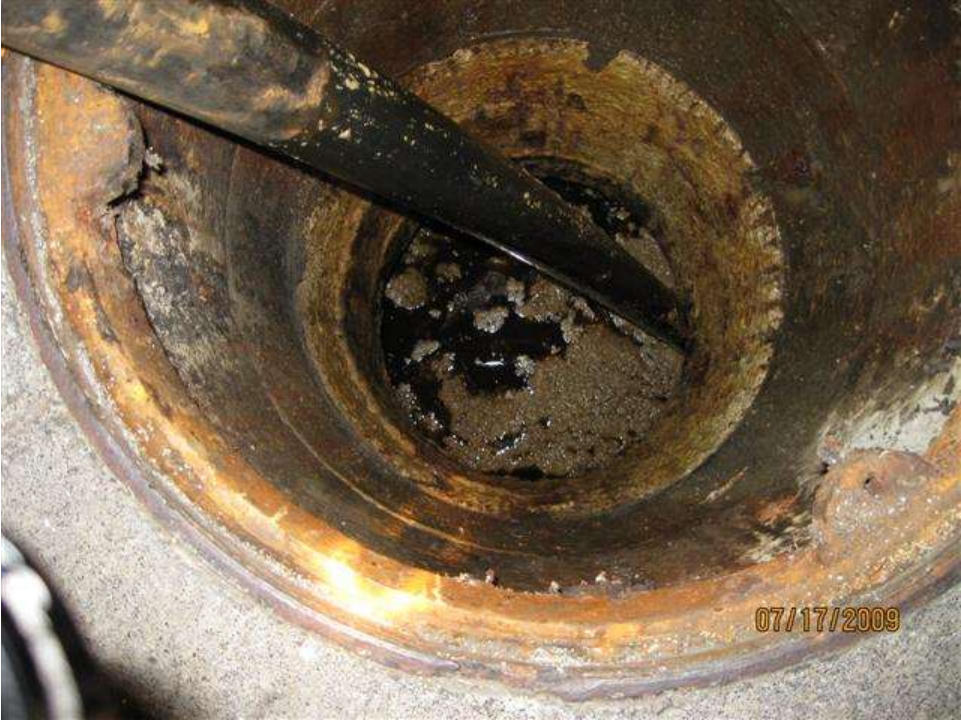
## 13 months in service

Inaccessibility for maintenance & inspection

- Problem for Plastic as well as fiber glass models

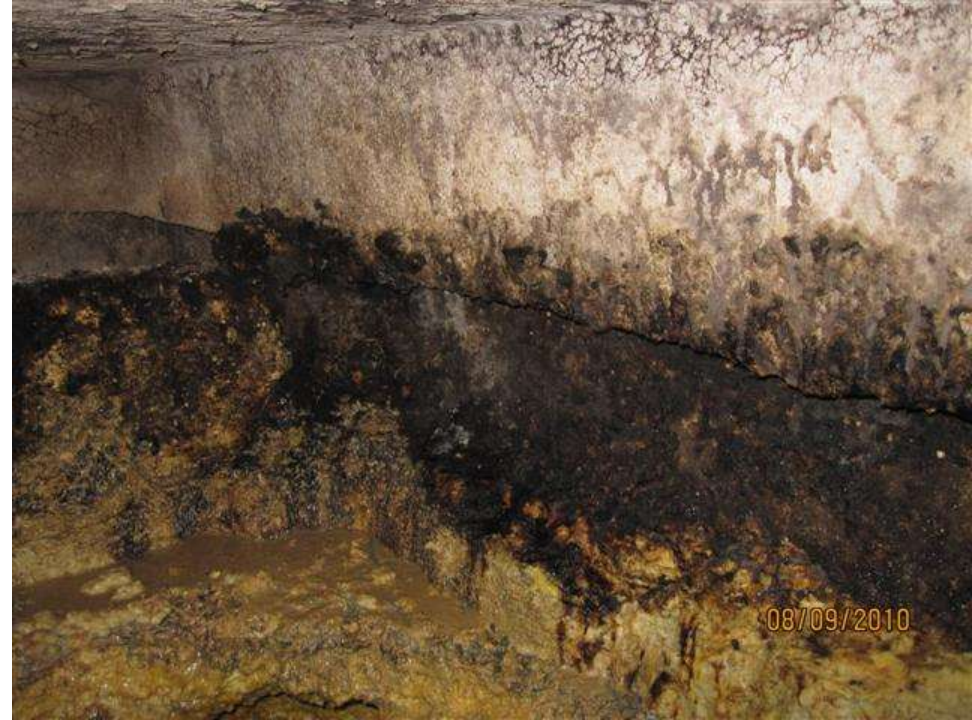
# Trying cleaning the Square through the Circle

I reached my arm past  
the  
24" concrete riser

What happens when  
the concrete riser is 7'

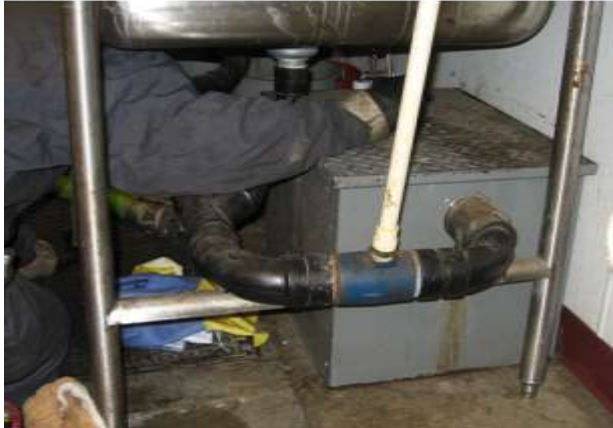
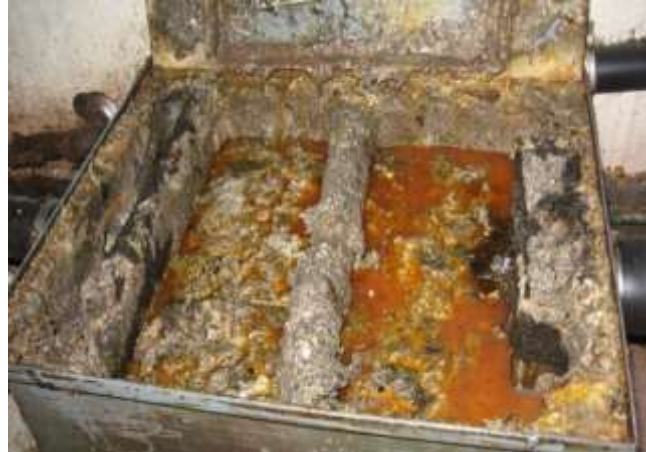
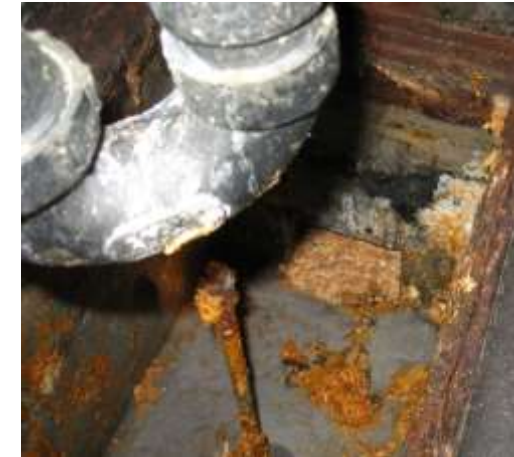
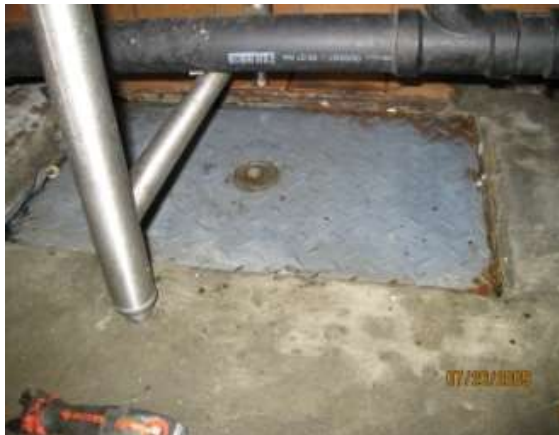
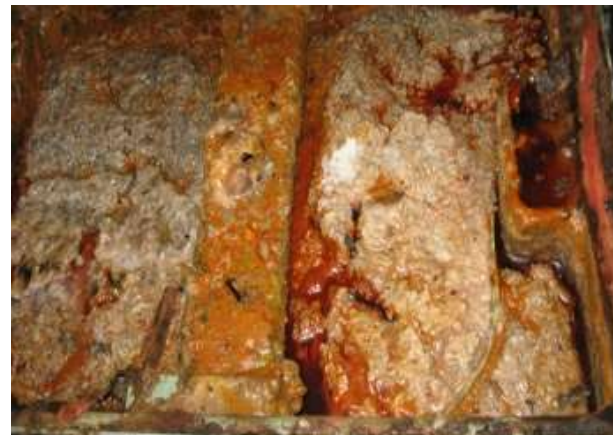
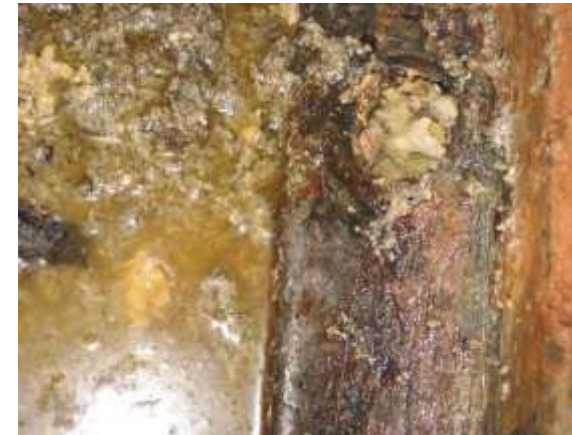
## Case Study: Survey Inspections find

- 95% of HGI are set-up with limited/difficult access
- Only 3 compartment sink is connected
- Not on a proper cleaning frequency!

How hard do we let them make it?

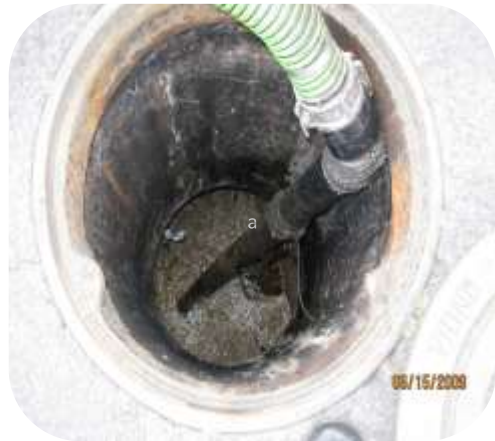
- 89% of GGIs have too many concrete risers
- 65% have accessibility problems due to landscaping
- 96% are not maintained effectively
- How many are already leaking?

**Short of getting inside !!**

- Proper cleaning is not happening

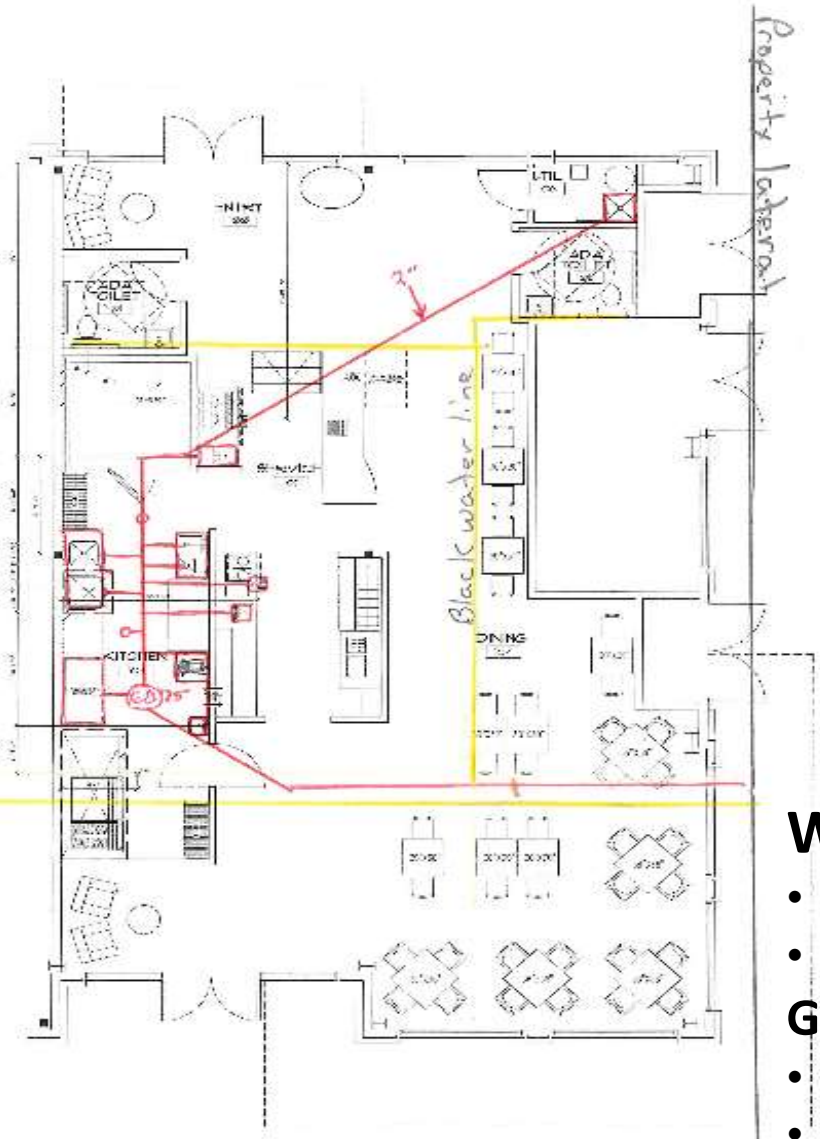
**Waste water is separated**

- Black Water = Yellow
- Grey Water = Red

**Grease Interceptor is still inside**

- Possible Backups inside food service area
- Possible septic hoses in food service area
- Possible mobile unit blowing exhaust in Food service area
