Force Main Condition Assessment

Water Environment School

March 2017

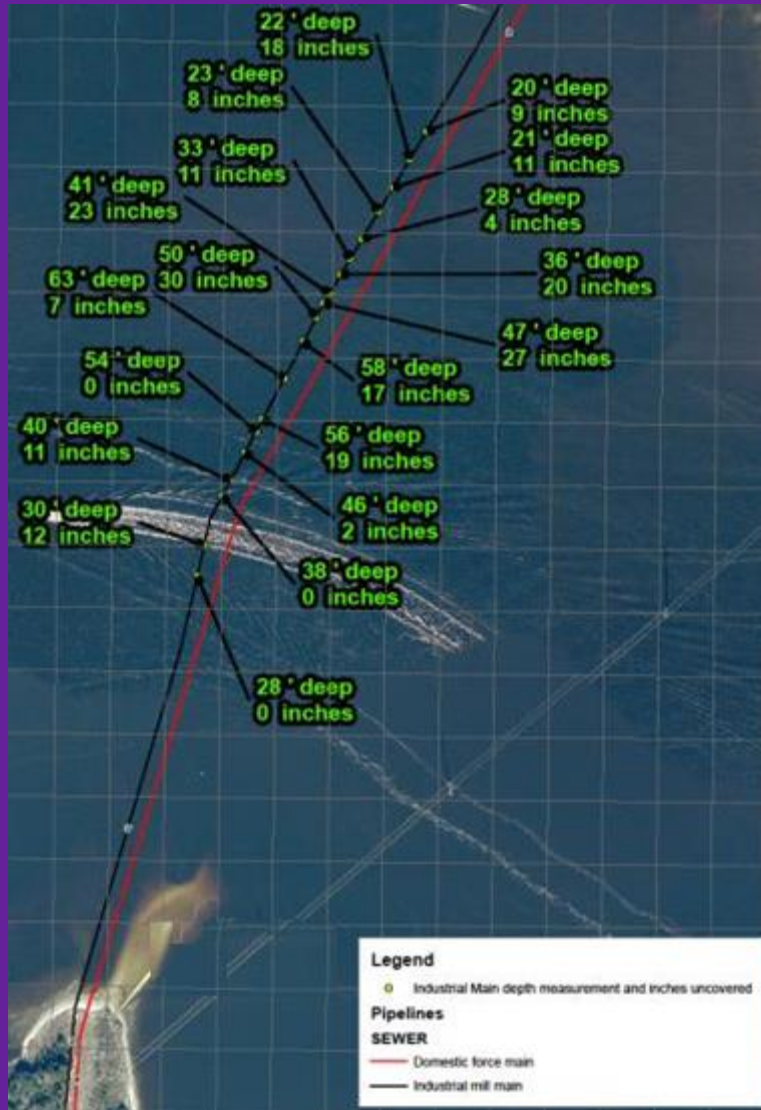
Portions of Subaqueous Pipe Uncovered

- Original construction included both restrained and unrestrained joints
- Installation was performed by commercial divers into a dredged trench
- Prior surveys indicated erosion had exposed portions of the water crossing

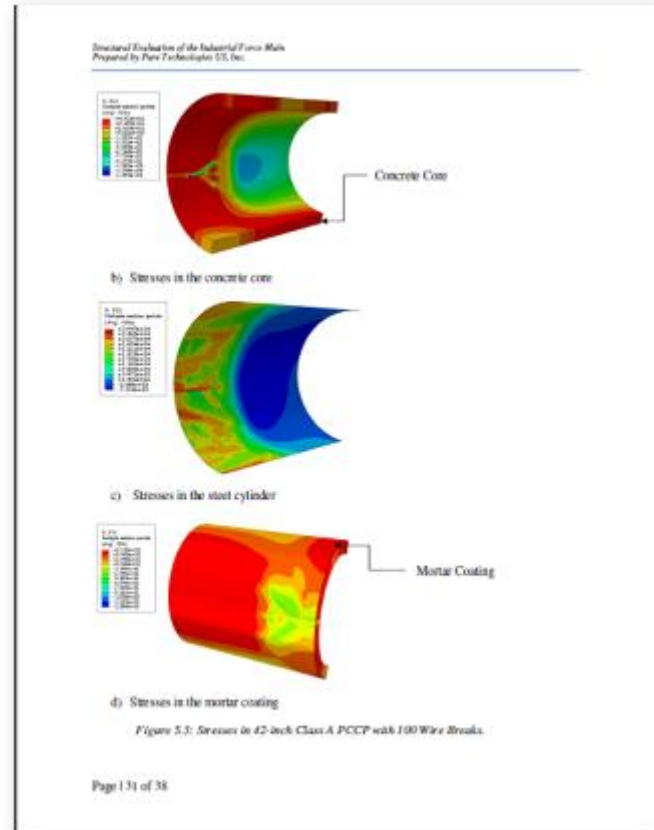
Seven Pipe Segments on 42" PCCP Adjacent to Aerated Lagoon Recommended for Replacement

Owner Elected Conservative Approach to System Improvements and Replaced Total 800 LF Reach

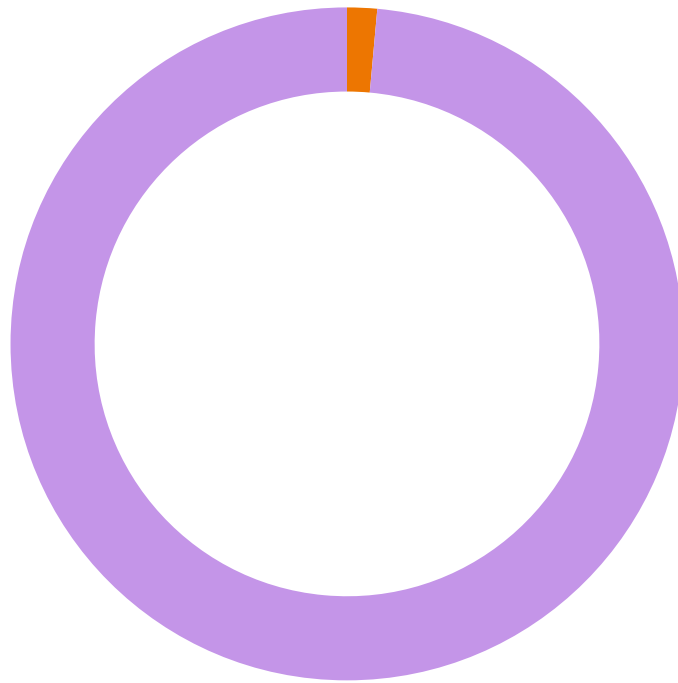
Pipe Condition

■ At-Risk ■ Good Condition
