**FOG**

**CHRONICLES**

**ORWEF March 2017**

**Grease Caused  
Sanitary Sewer Overflows  
2008 - 2013**

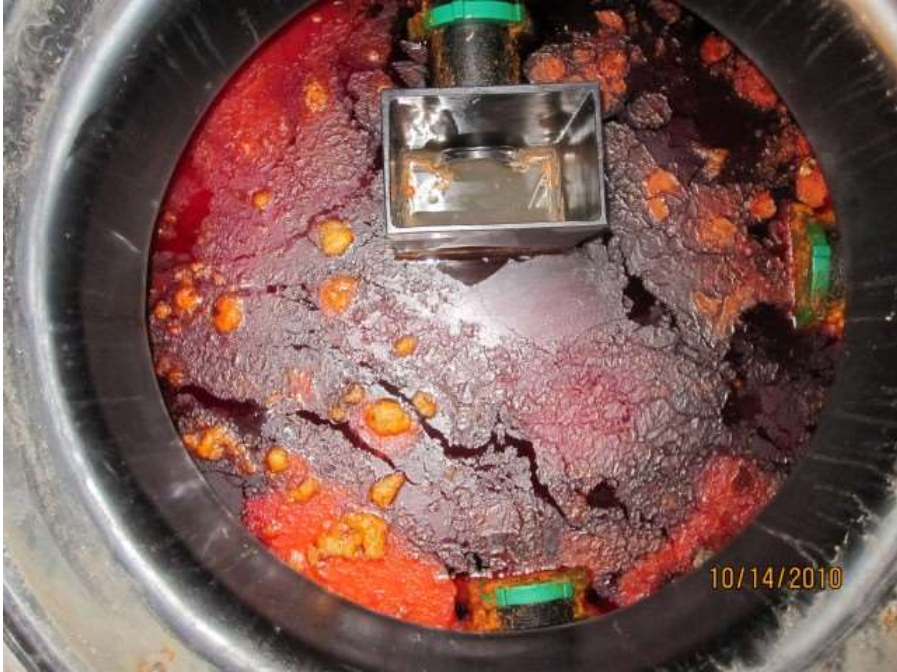
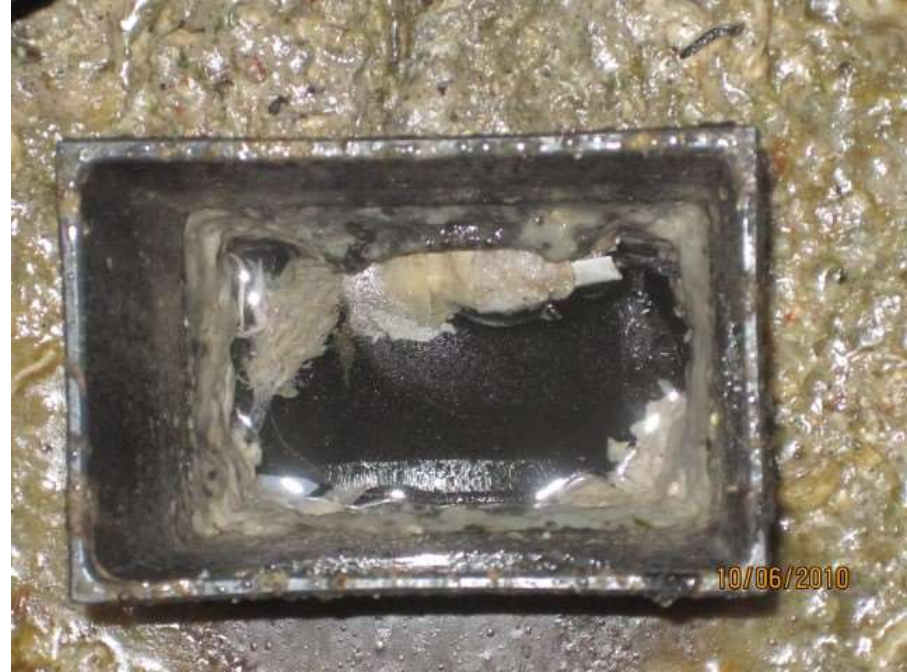
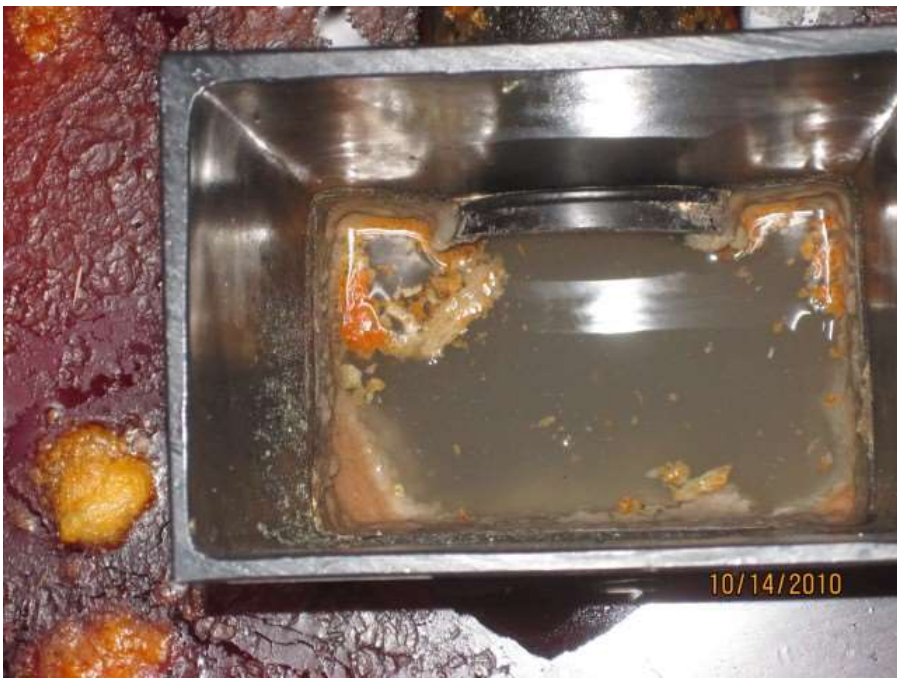
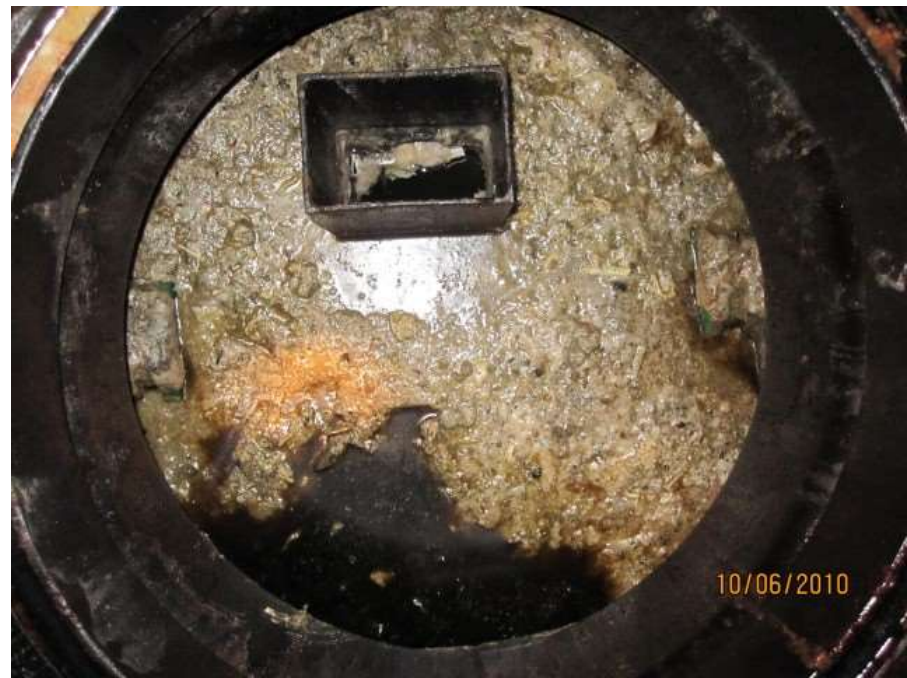
### **Cacaklacks & Zeeks - (2 more kitchens coming on board)**

- High food production
- Using 2 of 4 kitchens: No ware washing, only 3comps, Handwash (s), Foodprep (s), floor drain (s)
- Plumbing Engineer's design - anticipated 30 days (Regulatory Frequency 20 days)

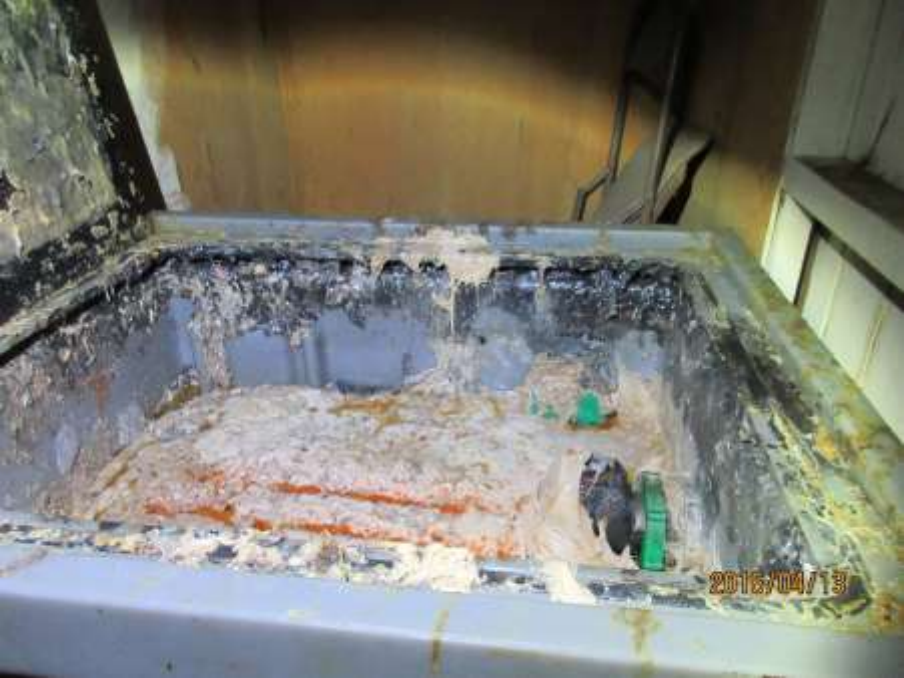
**Between 180 - 260 days after additives were stopped from being used**

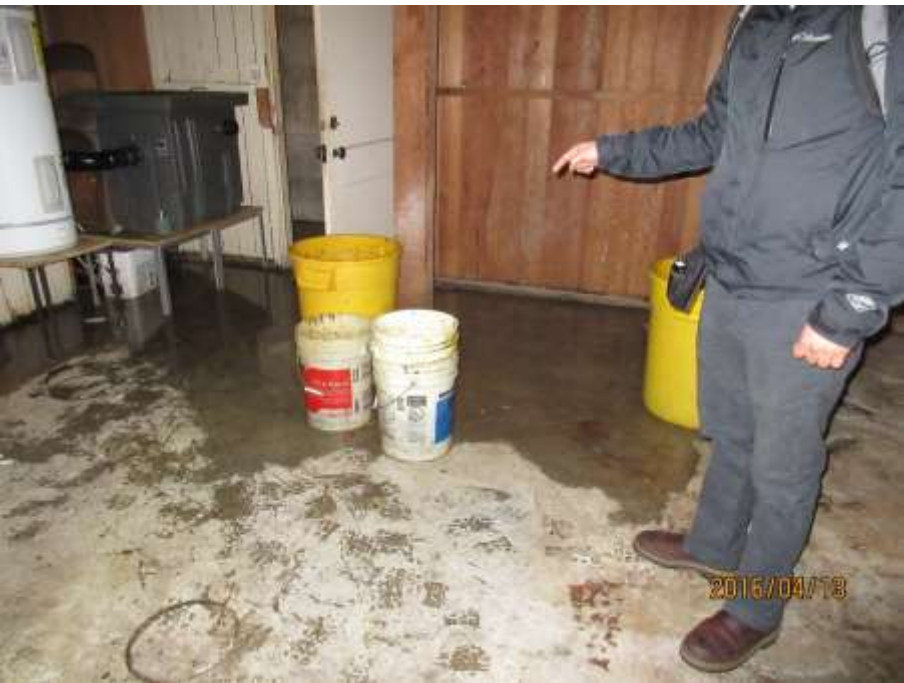
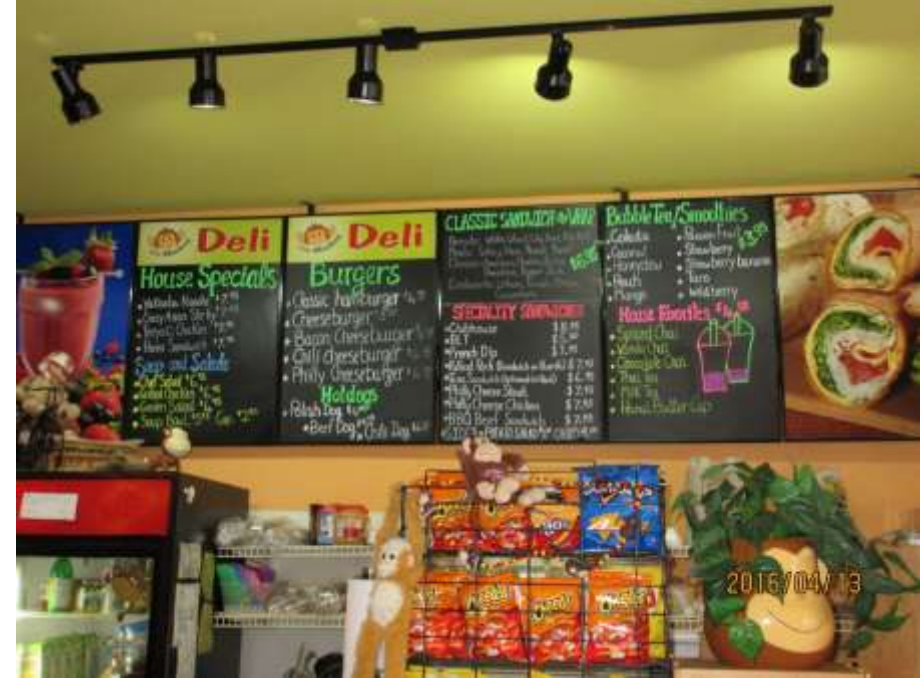
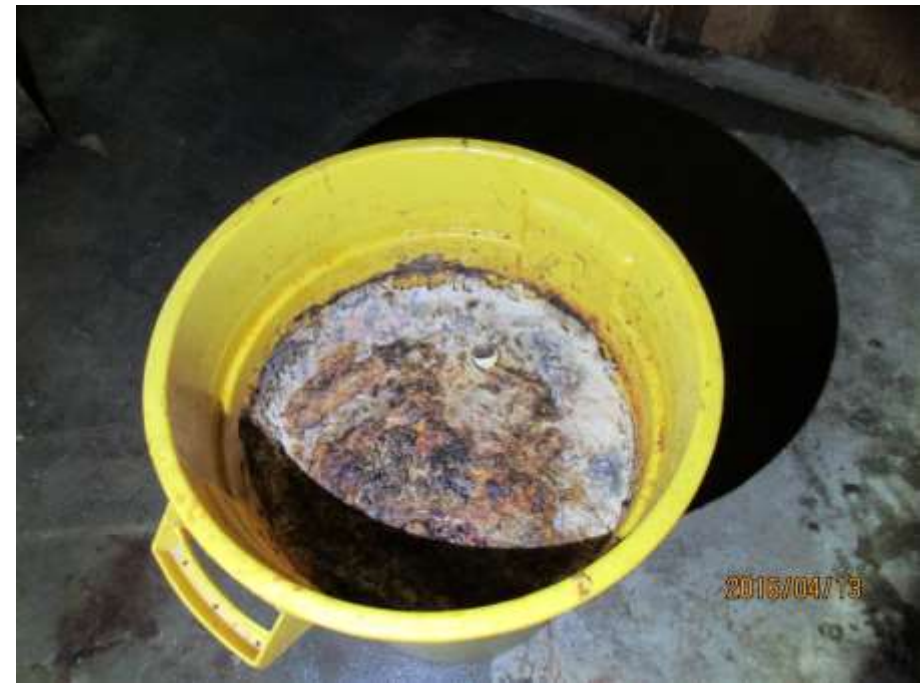
## County Health Dept closed FSE

### Chronic issues with Back-ups

- Understand reason for backups
- All F&D connected
- 3comp, handwash, Prep, Mop
- Pumper info – long time since service, outstanding bill
- Potential to impact food service in leased space next door
- Potential to cause health hazard in building
- Next door creates far more FOG
- HGI's same brand/model
- No issues – next door

- Service HGI
- Jet line between HGI & Public
- Provide invoice for services rendered

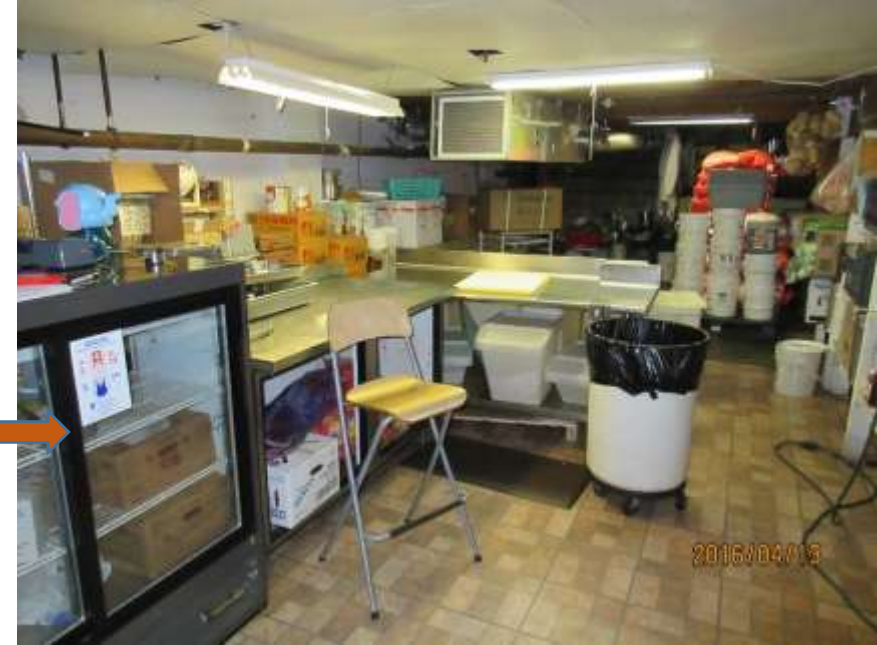
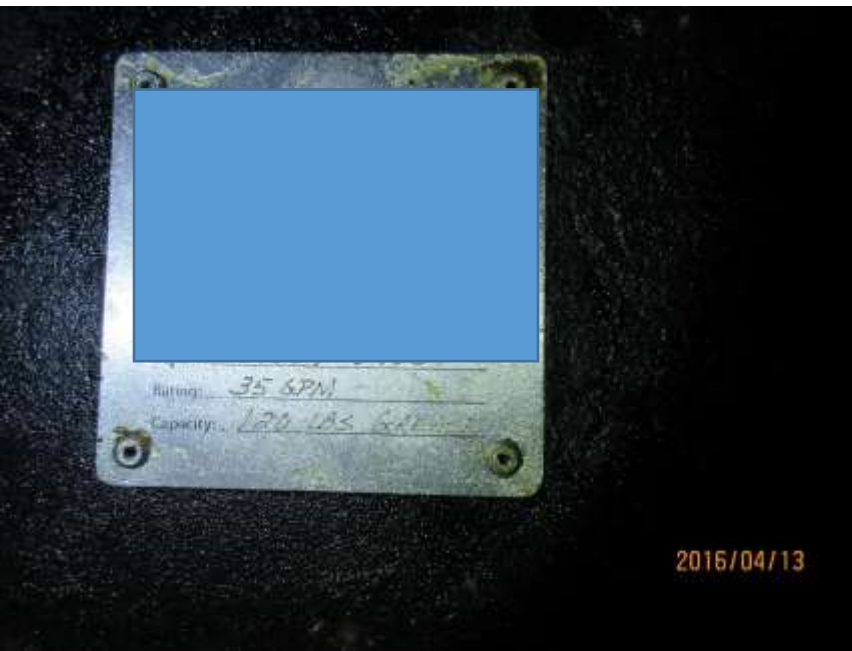
## FSE Thai - food service

Basement space Next door

- Drains & utility sink not connected
- This food service is in the basement
- Far more FOG production here

### Same size of HGI

- Dishwasher is hooked-up
- Except drains in upper right photo
- HGI too small for operation
- Flushing out HGI and pushing to Public

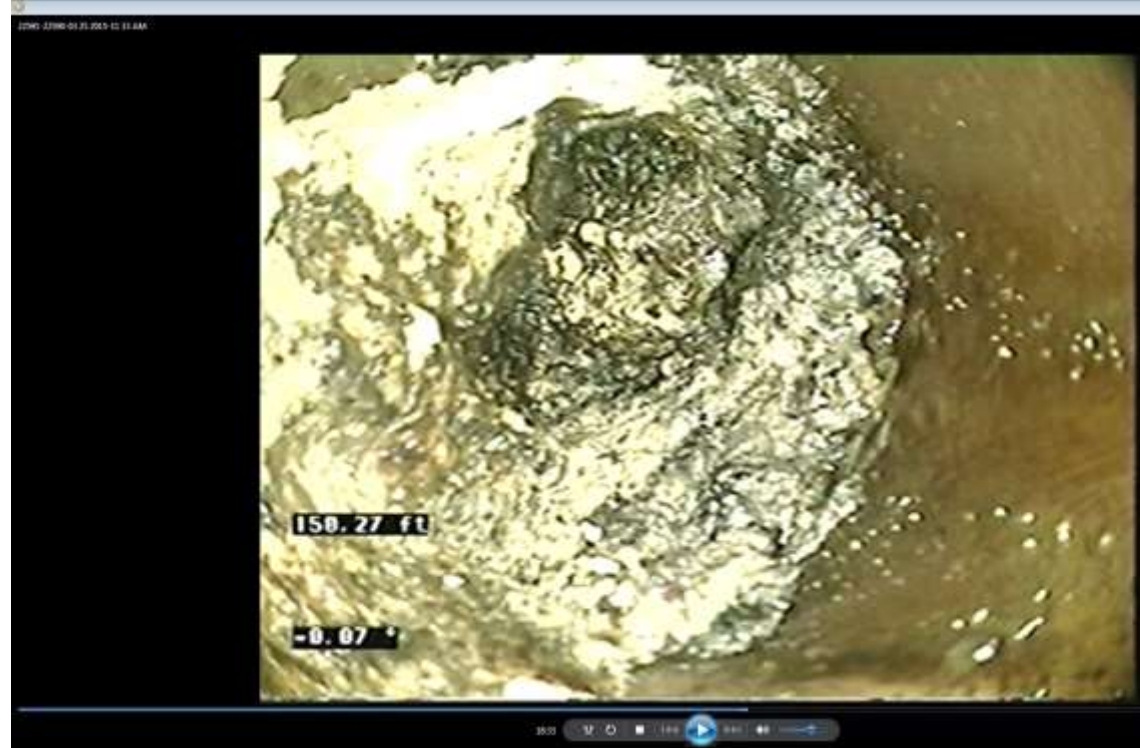
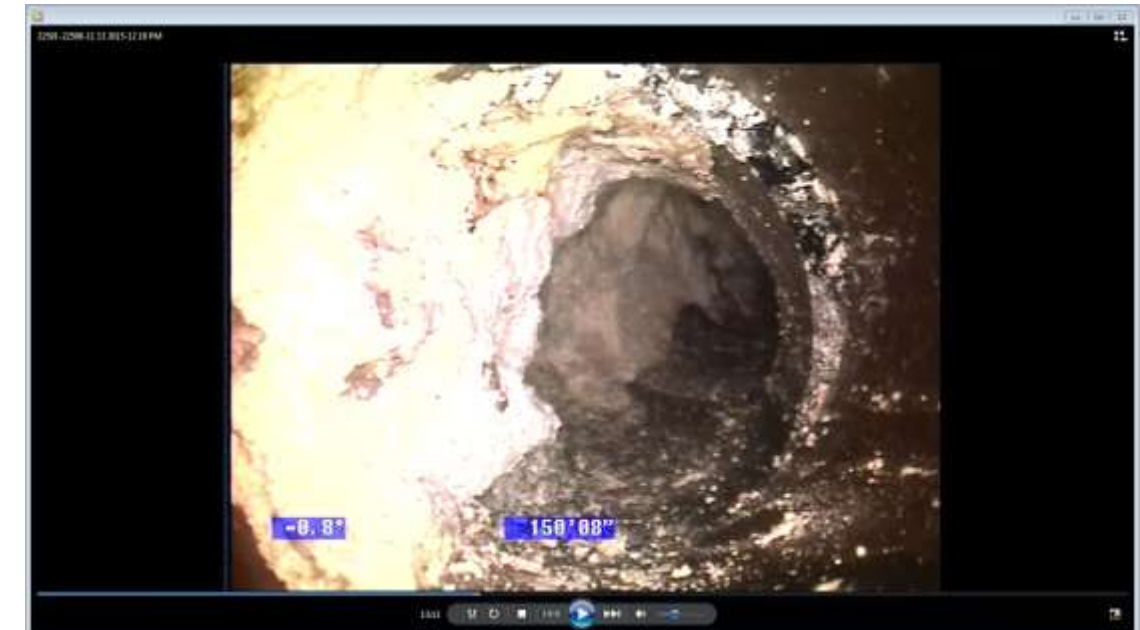
Describe the cause of the overflow and the City's response to stop and clean up the overflow: The Las Parrillas business operates a commonsary out of this building. The operator on site told us he selfcleans the outside grease trap. He said he also runs a snake down his lateral fairly often and recently hired a contractor to water jet his lateral about a month ago. The grease blockage in the main Line was isolated to this lateral and was what caused the overflow into the business' basement. For this reason the City's leagle team opted not to help with the cleanup. City crews jetted the main line to clear the blockage and restore flow. This line was previously cleaned and TV'd last March of 2015. At that time grease was observed in the lateral of this business (see provided pictures). Our F.O.G personal spoke with the owner about the grease issue.

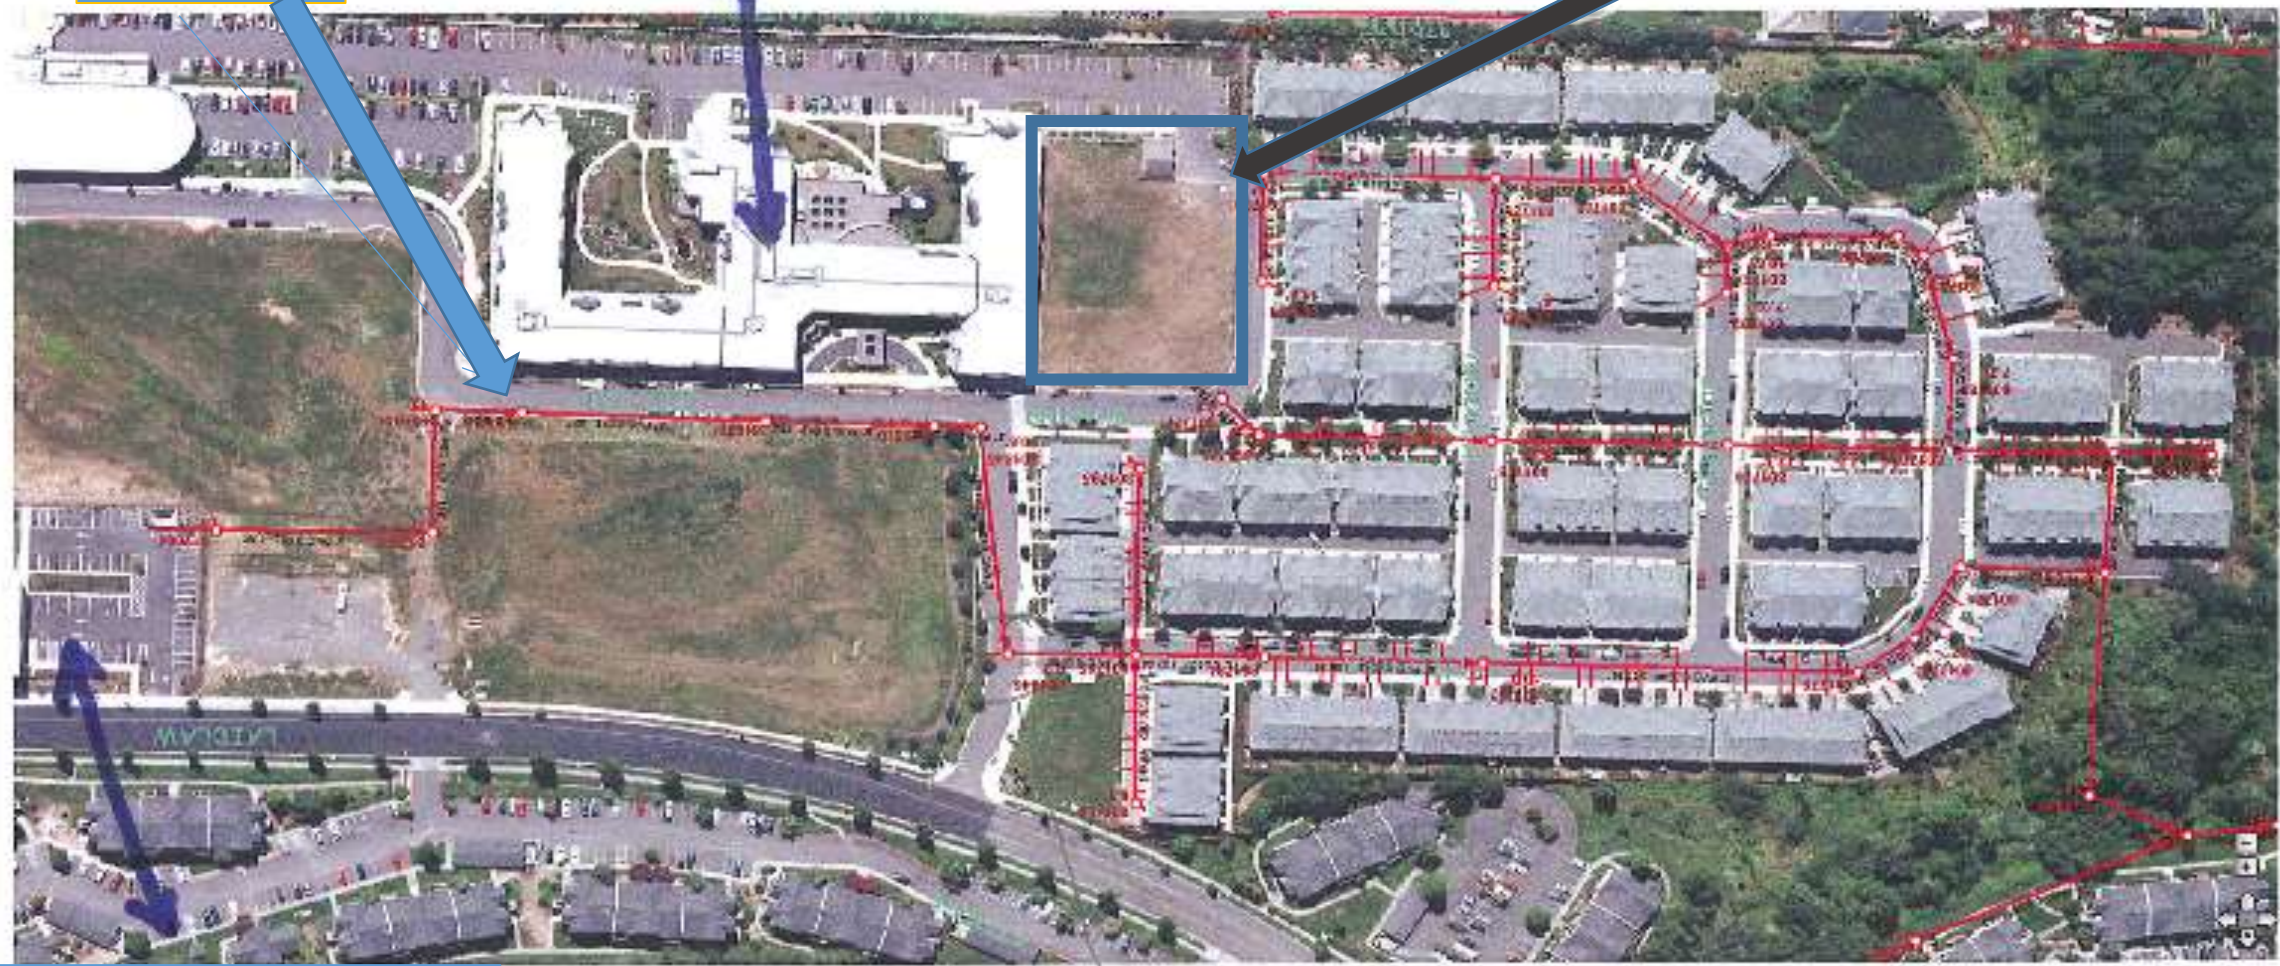
**MH 801844**

**Nursing Home  
220 meals/day**

**Top of the Line  
Medical Building  
No food service**

**1<sup>st</sup> MH with FOG issues  
Laurel Parc is the only FSE  
discharging to this point.**

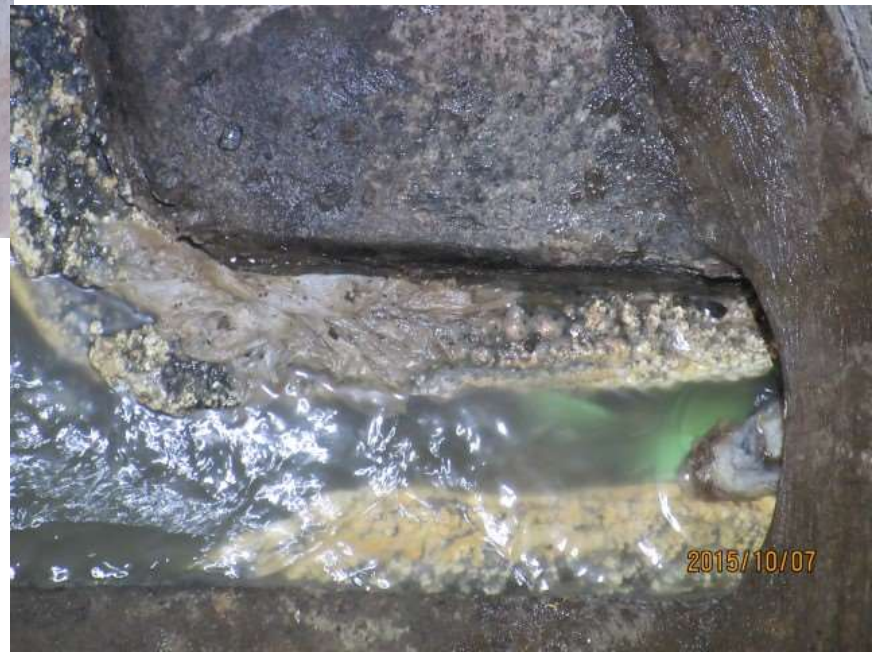
MH 801785

**Downstream MH**

**The Perfect Strom**

**Anything can  
dislodge  
this  
grease log**

**Two other feeds  
coming into MH**

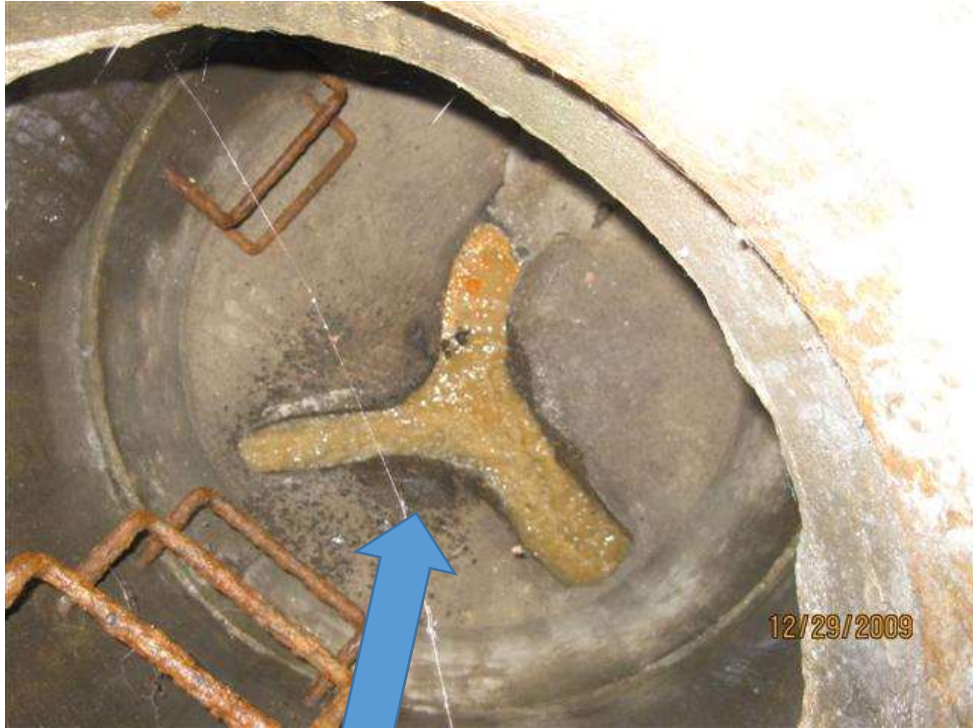
First cycle  
from  
dishwasher  
impacting  
downstream MH

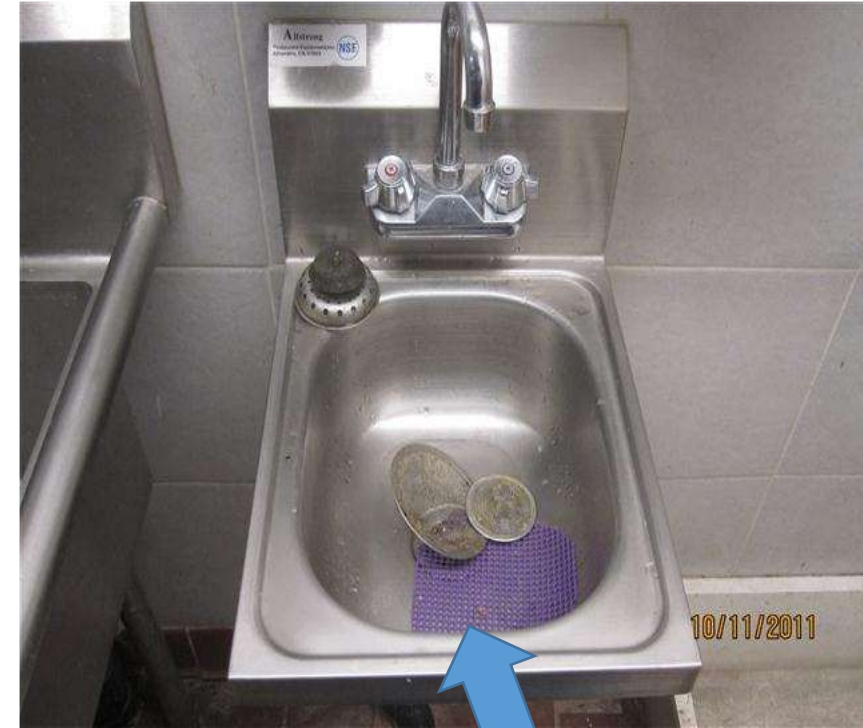
Screens in handwash sink  
used to dump something

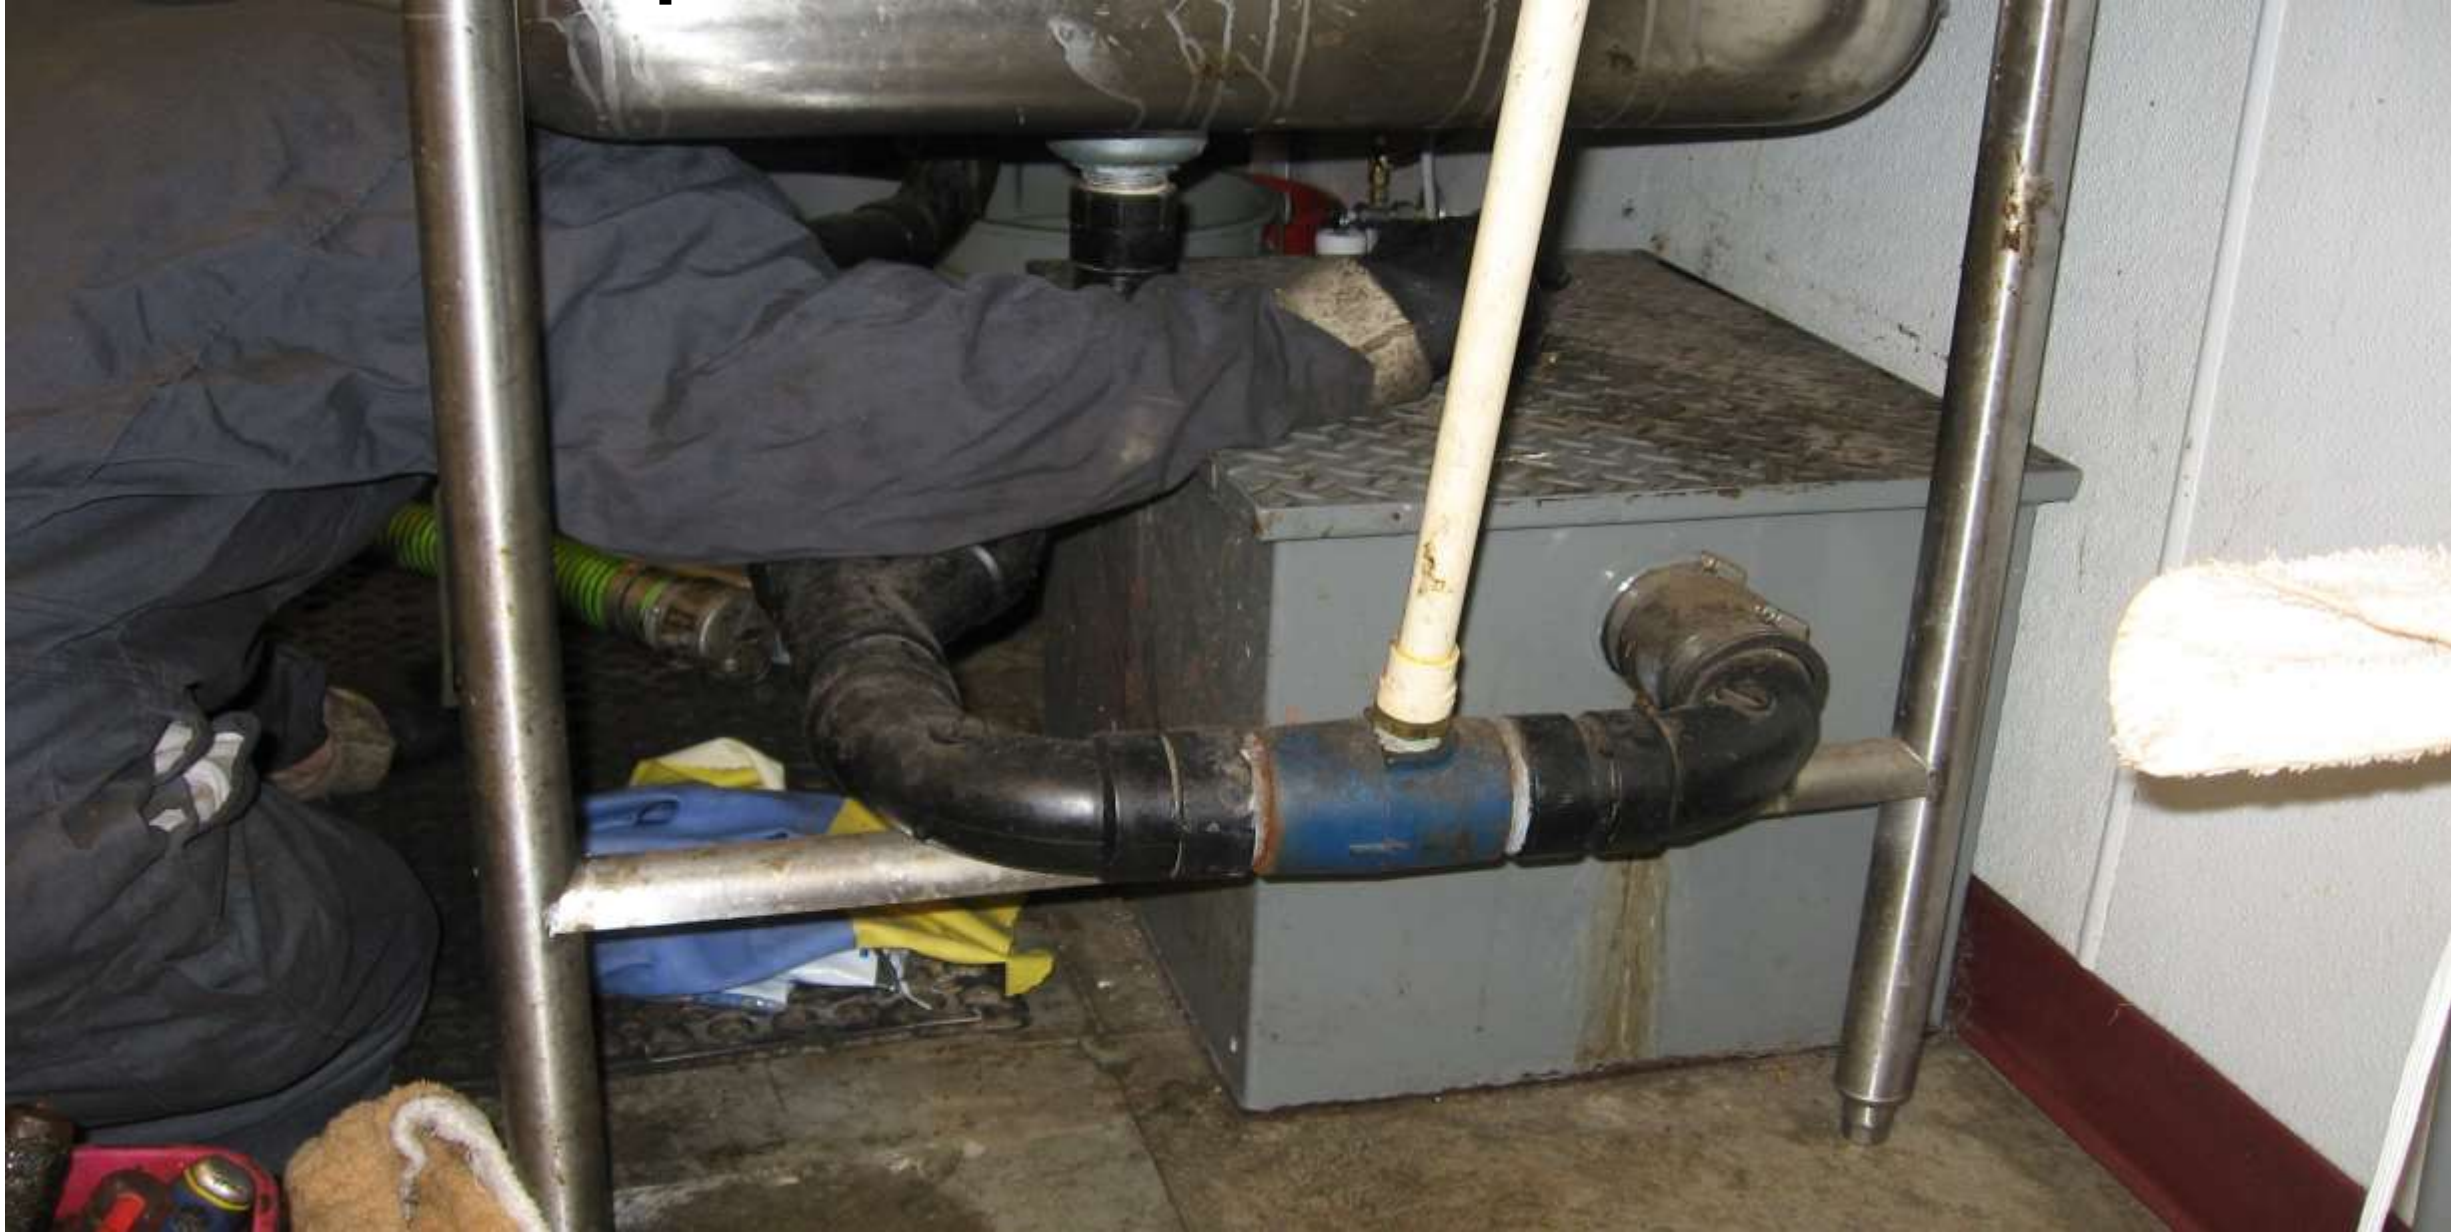
**Can't get lid off  
pushes hose in to vacuum**

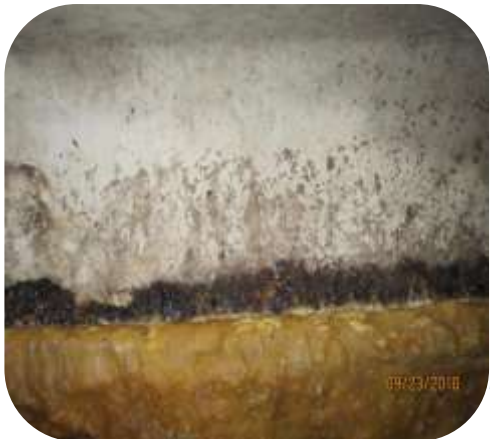
**Short of getting inside !!**

- Proper cleaning is not happening

**Long Term Investment**

- Cut from 30-40 to 7-15 years

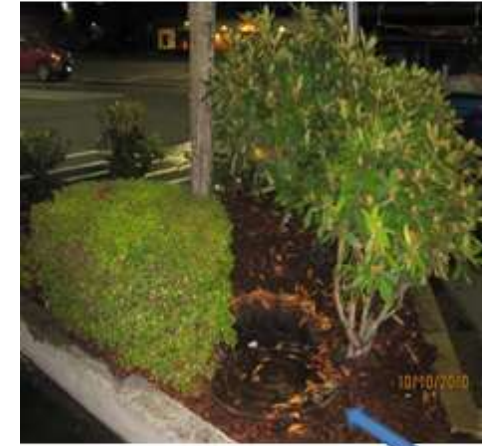
## GRD Location is Very Important

Where's the accessibility to PRESSURE WASH

Did this really get dug out for every service?
